# Lake Thunderbird Association

May 29, 2025 • Putnam, IL

RESERVE STUDY

Lake Thunderbird Association  
Putnam, Illinois

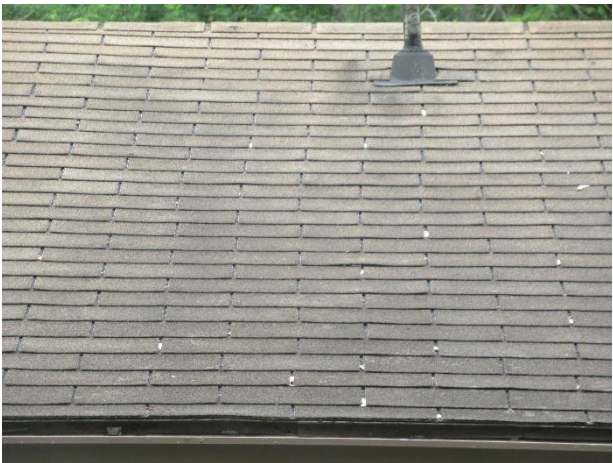
Shingle lift, curl and stains visible throughout campground shower building roof

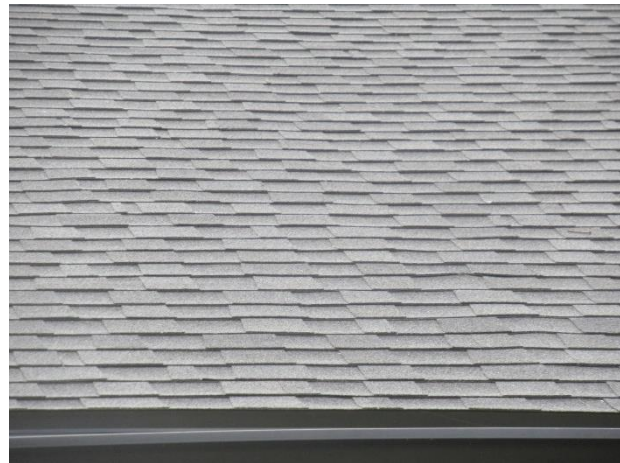
Laminate shingles in good condition at clubhouse roof

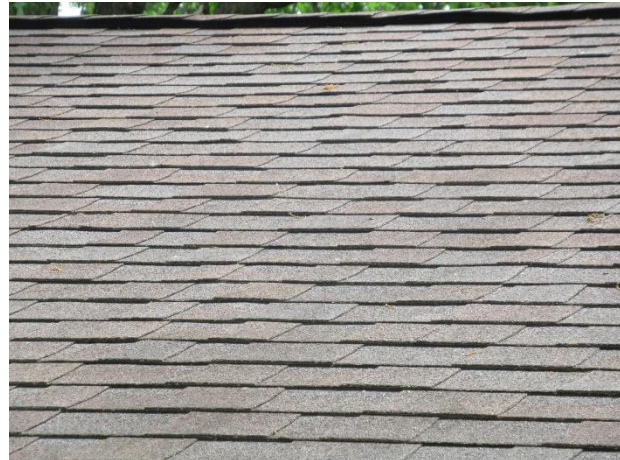
**Minor wear and granule loss visible at Snack Shack roof**

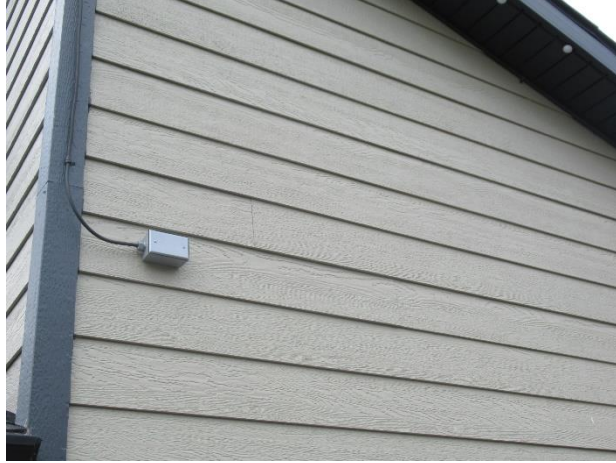
**Siding and finish in good condition**

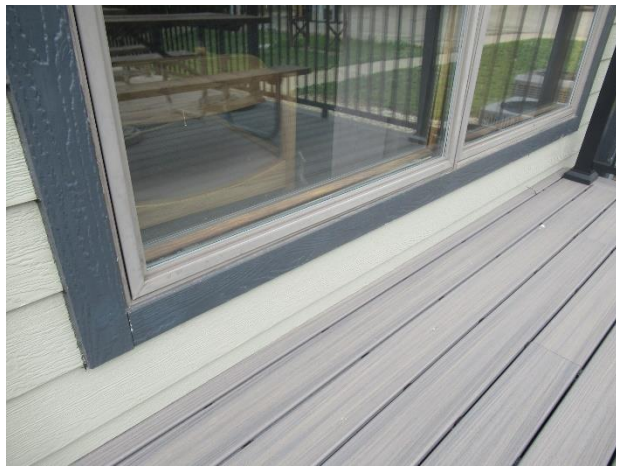
**Aluminum frame in good condition**

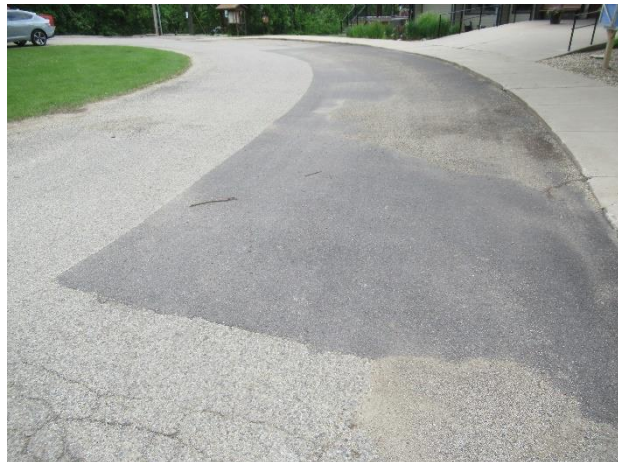
**Large pavement patch at clubhouse parking area**

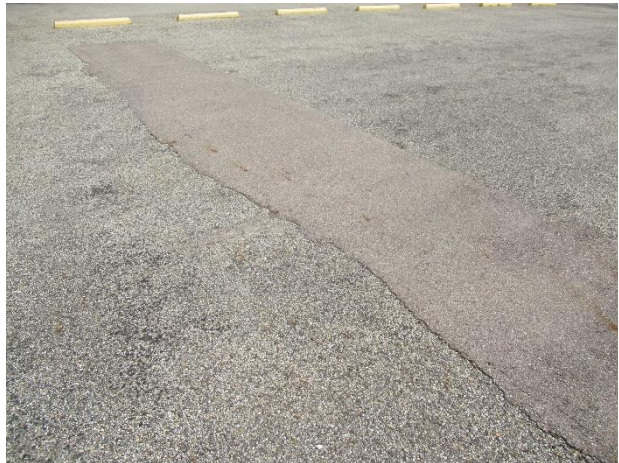
**Pavement patch at beach parking area**

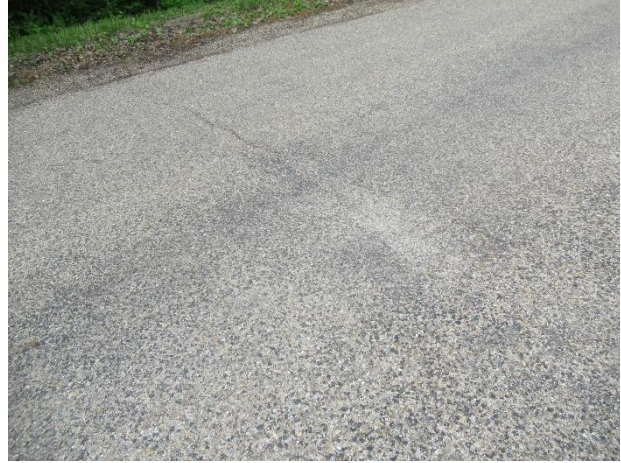
**Isolated instance of significant settlement at private street pavement**

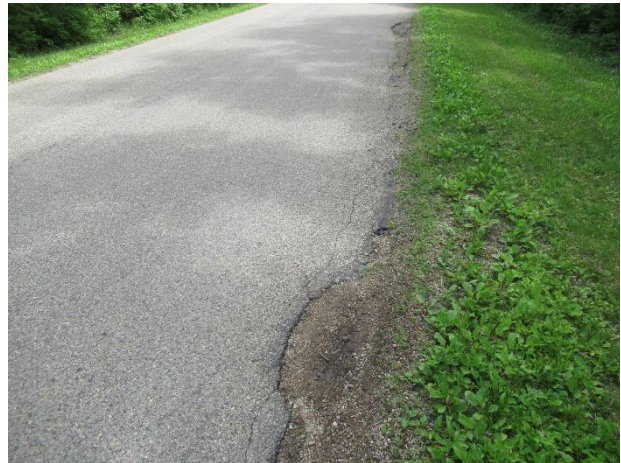
**Street edge deterioration**

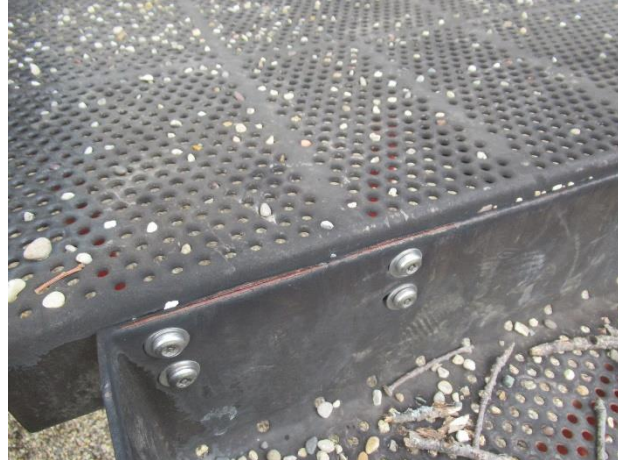
**Playset platform deterioration**

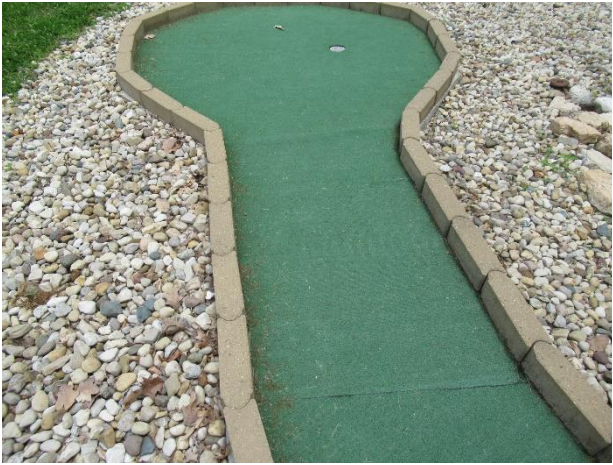
Putting green carpet deterioration

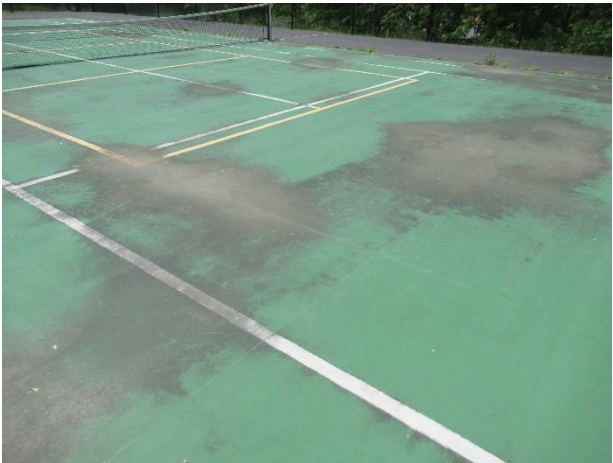
**Significant color coat deterioration**

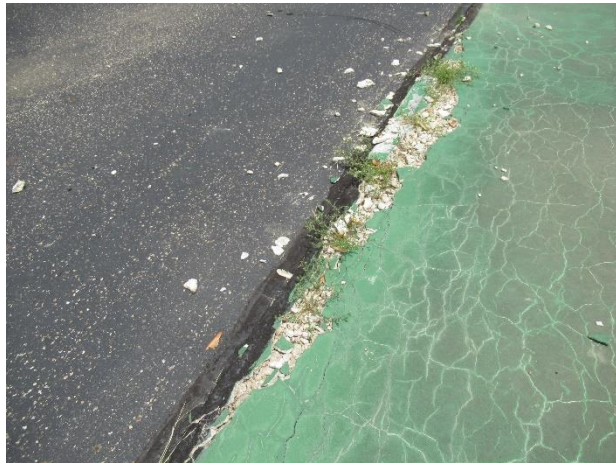
**Excessive asphalt deterioration**

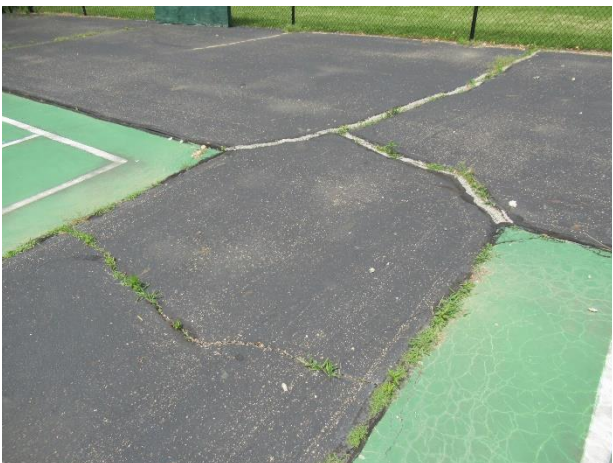
**Large cracks found throughout tennis court**

***Preventative Maintenance Notes:*** Prior to the application of the color coat, the Association should require the contractor to rout and fill all cracks with hot emulsion. This deters water infiltration and further deterioration of the asphalt playing surface. We note

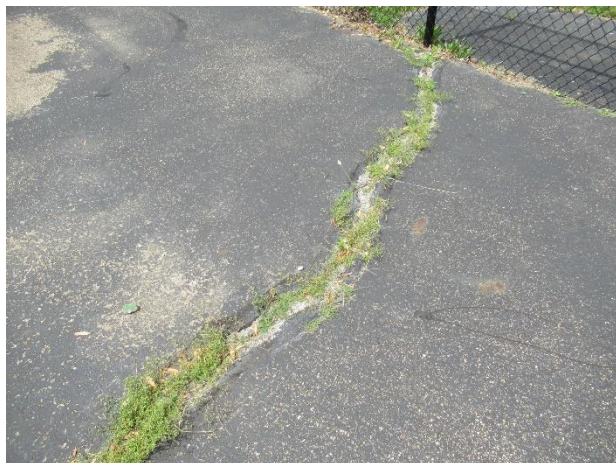
**Large cracks found throughout tennis court**

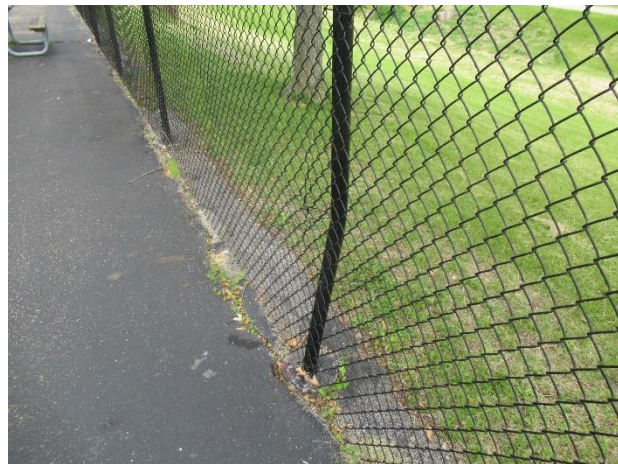
Tennis court fence deflection

**Useful Life:** Up to 25 years. We recommend replacement in conjunction with the asphalt surface due to the interrelated nature of these events.

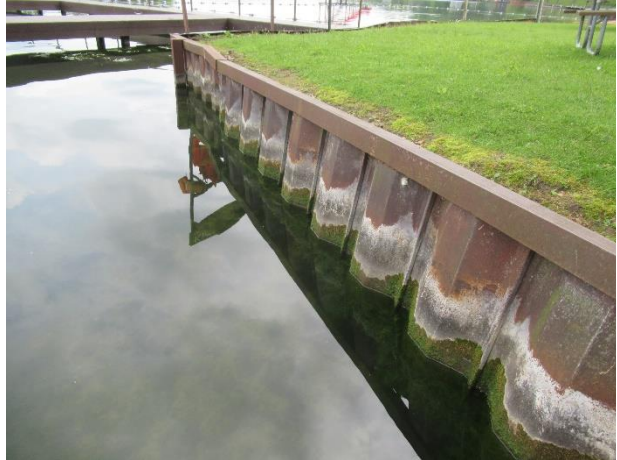
**Deflection and deterioration at beach bulkhead**

**Useful Life:** Bulkheads of this type have useful lives of up to 50 years. Due to the varied ages and conditions observed, we include a phased, ongoing approach to replacement.

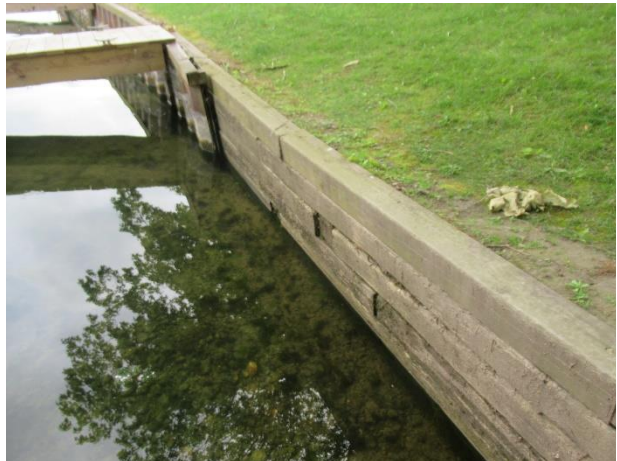
**Deflection and deterioration visible throughout wood timber bulkhead area (replace with steel)**

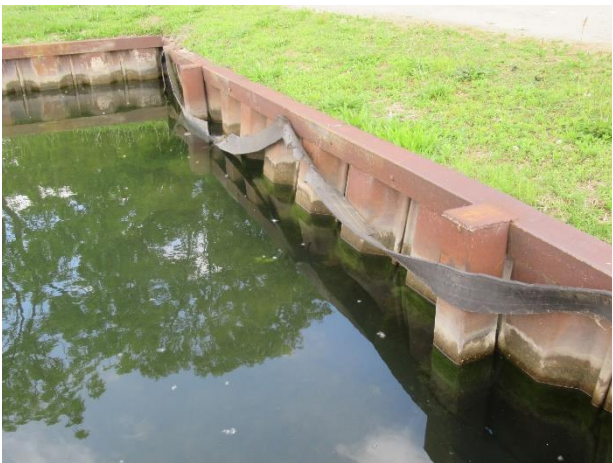
**Deflection at clubhouse dock area bulkhead**

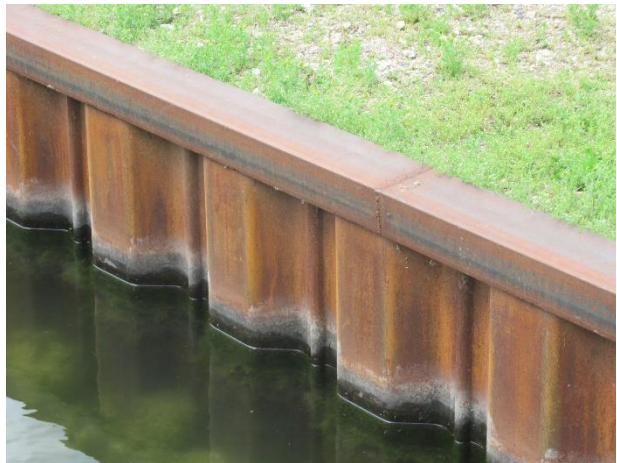
**Section of clubhouse dock area bulkhead in good overall condition**

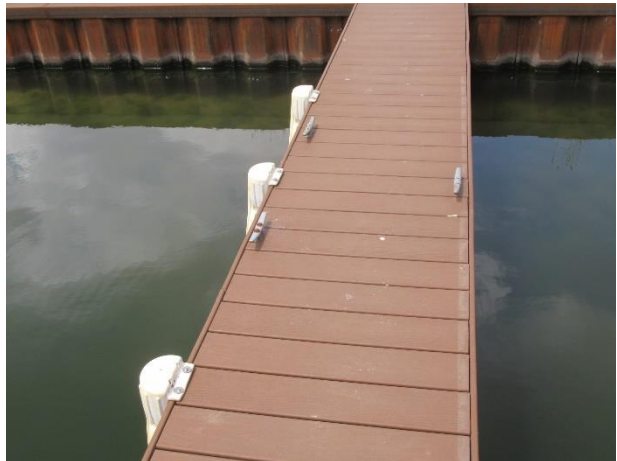
**Recently replaced clubhouse dock in good condition**

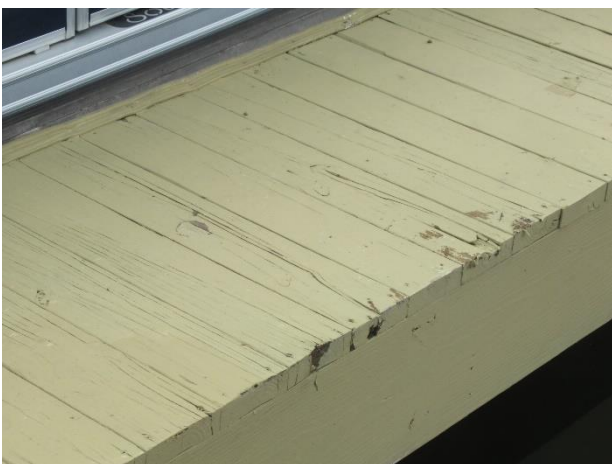
**Wood deck board weathering at older section of clubhouse docks**

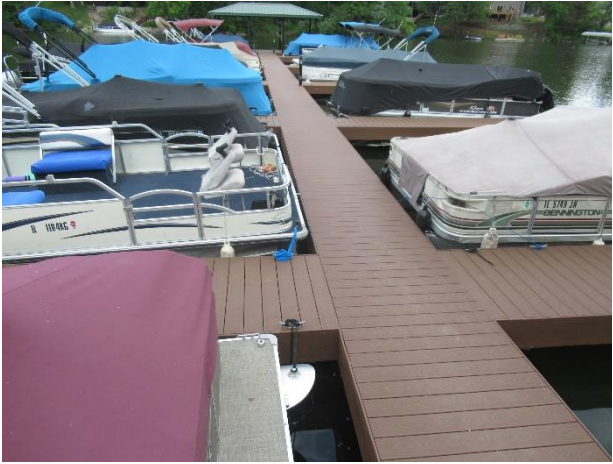
**South boat launch docks in good condition**

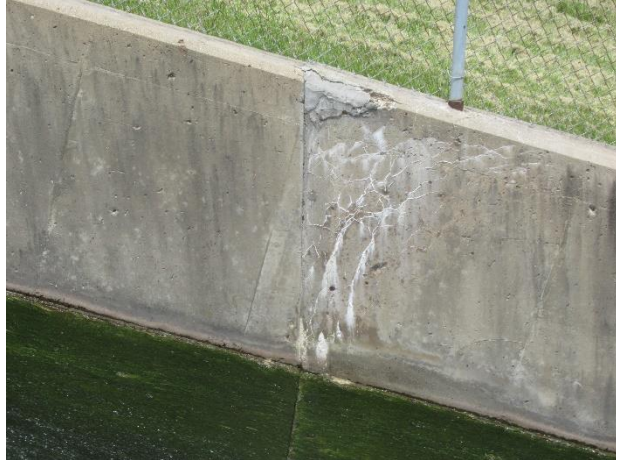
**Deterioration and previous repairs visible at spillway walls**

**Useful Life:** Up to 70 years with inspections and repairs performed every 6- to 10-years. The inspections and repairs should also include the weirs, culverts and other devices located at lake inflow areas.

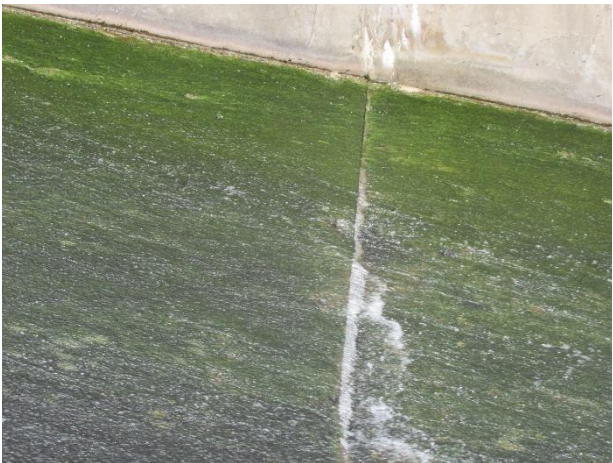
**Deterioration at base concrete isolated to control joint areas**

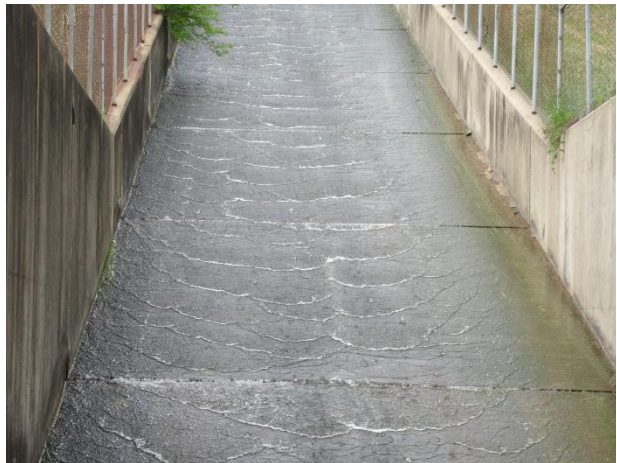
**Spillway base concrete in good condition**

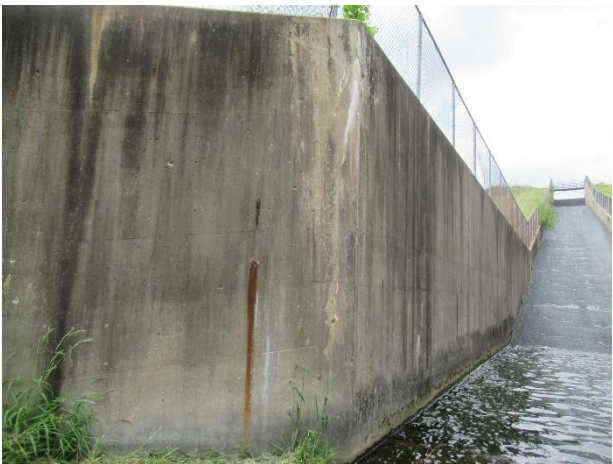
**Spillway wall cracks**

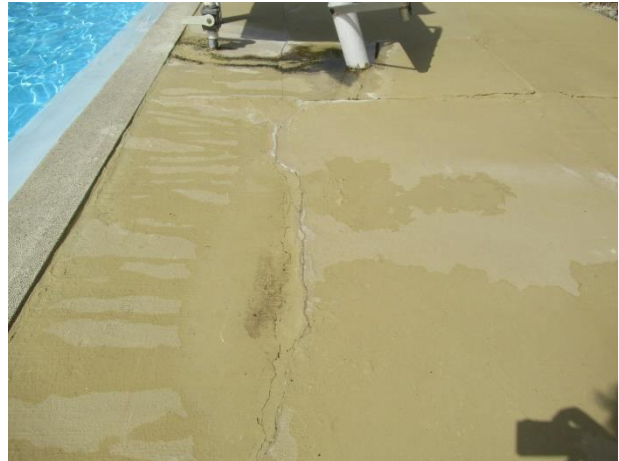
**Concrete cracks at deck**

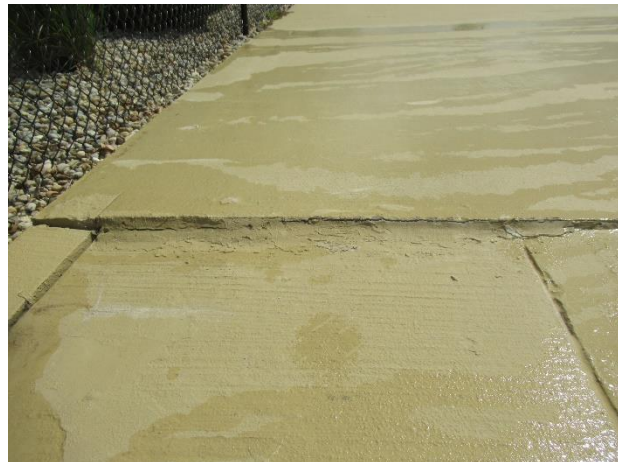
**Isolated trip hazard at control joint**

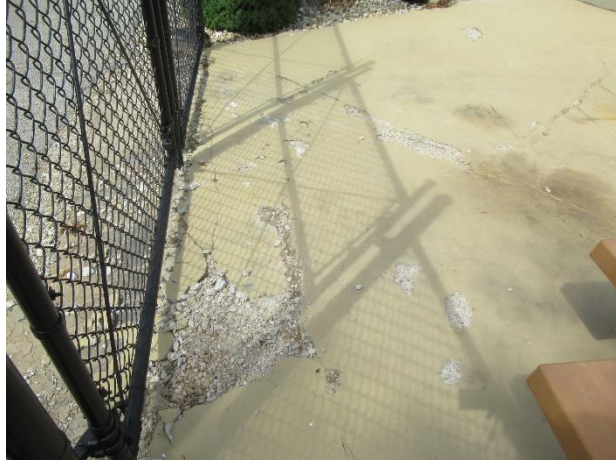
**Coating deterioration**

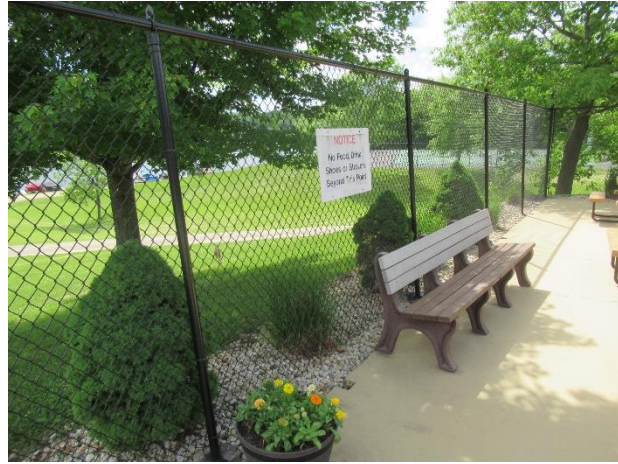
**Chain link fencing in good condition**

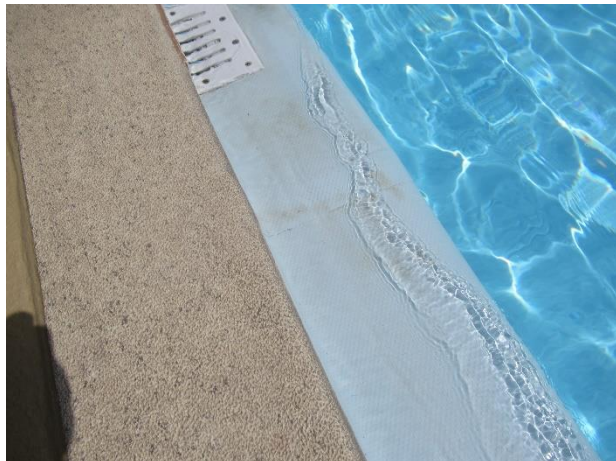
**Loose liner**

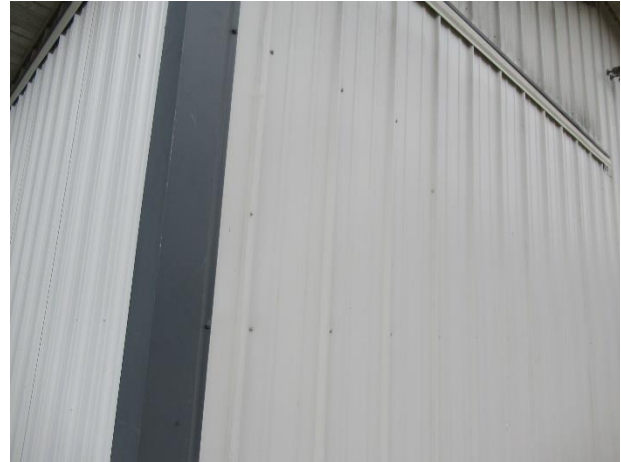
**Siding in good condition**
