# Lake Thunderbird Association

May 29, 2025 • Putnam, IL

RESERVE STUDY

Lake Thunderbird Association  
Putnam, Illinois

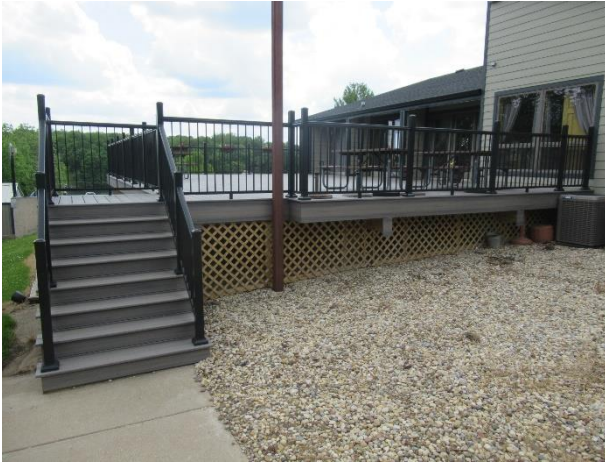
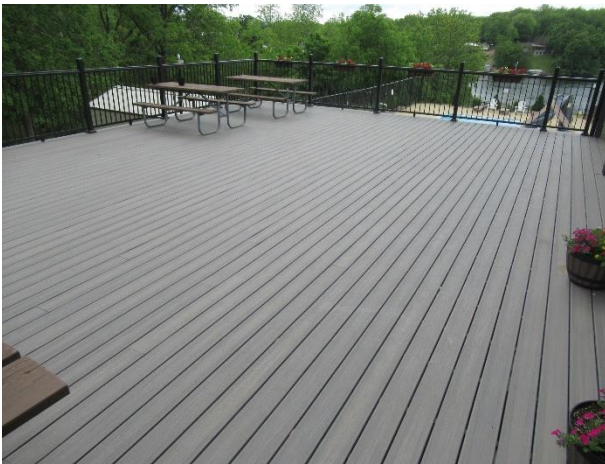
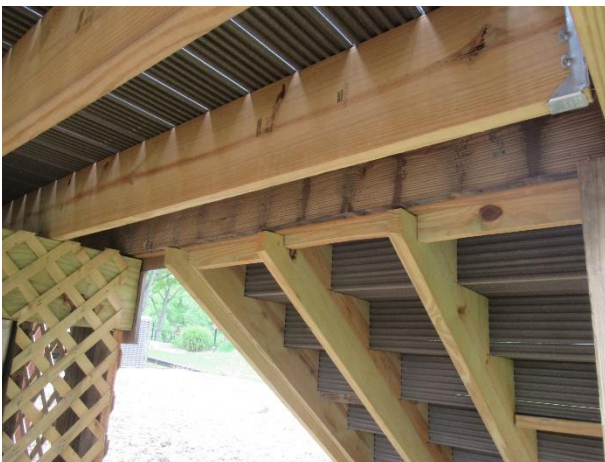
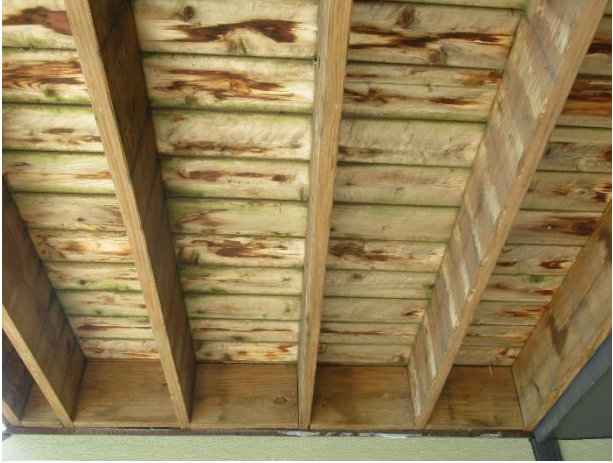
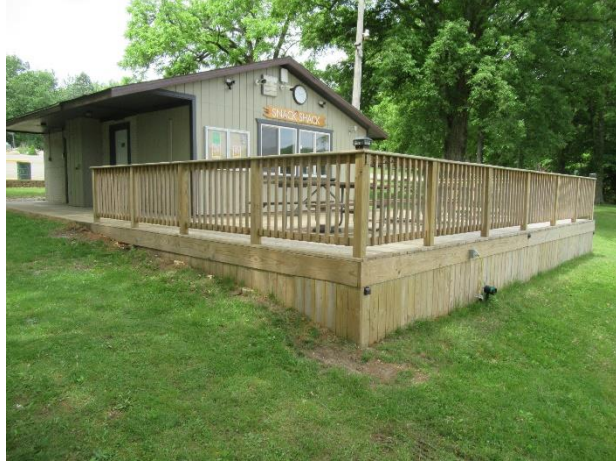
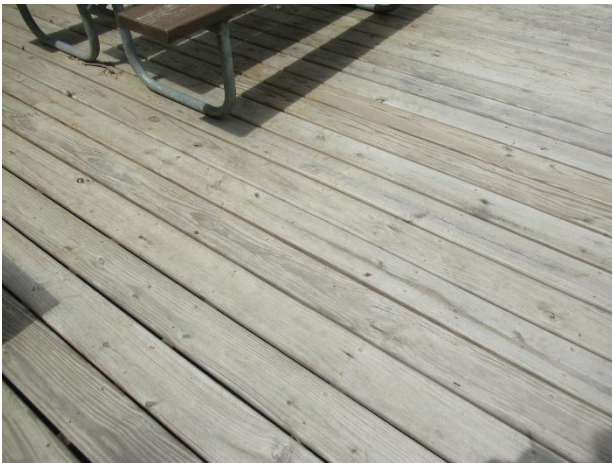
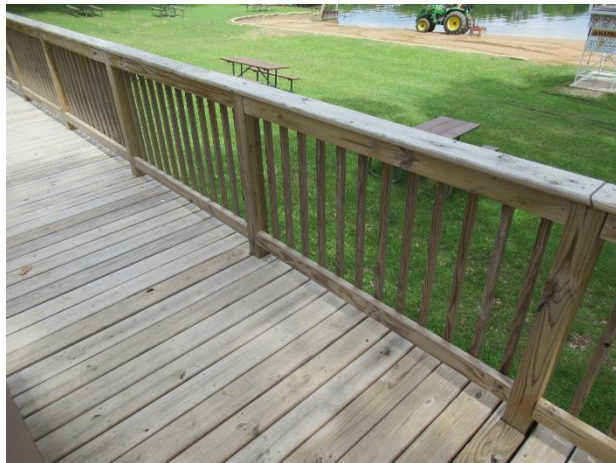
**History and Condition:** The side elevation clubhouse balcony was recently replaced and is in good condition. The ages of the remaining balconies were not provided at the time of our site visit but likely do not exceed 10 years of age. These balconies are in good to fair overall condition. We base our recommended timing of replacement based on the observed conditions.

**Deck boards in good condition**

**Underside of deck boards and wood joists at clubhouse south balcony in good condition**

**Snack Shack balcony deck boards in good condition**

**Snack Shack balcony railings in good condition**

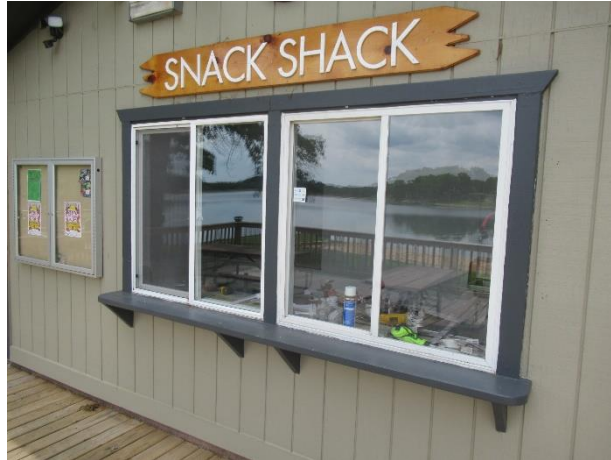
**Condition:** The siding and paint finish application is in good condition. We recommend the Association continue to fund for routine paint finish applications and repairs using funds from the operating budget to maximize the overall useful life of the siding.

**Plywood siding and windows**

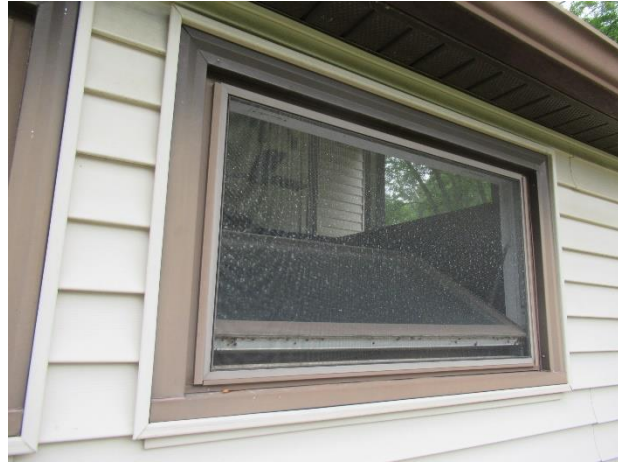
**Condition:** Fair overall

**Vinyl siding with a clapboard profile at campground shower building**

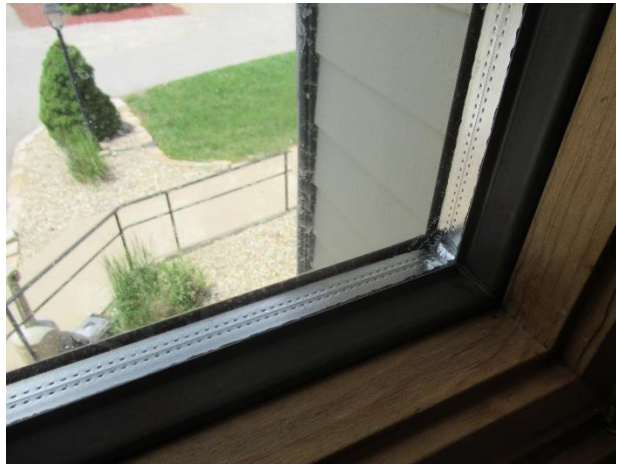
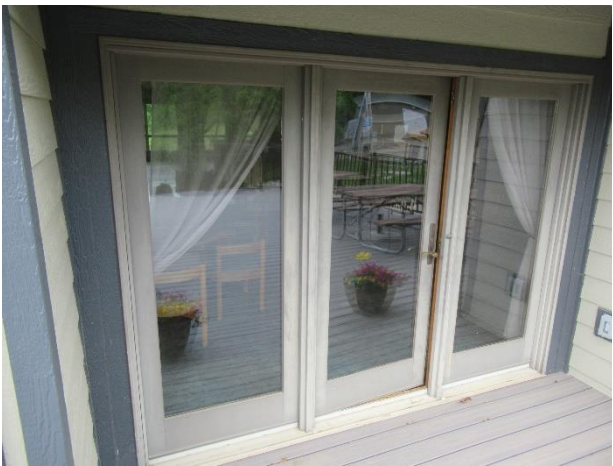
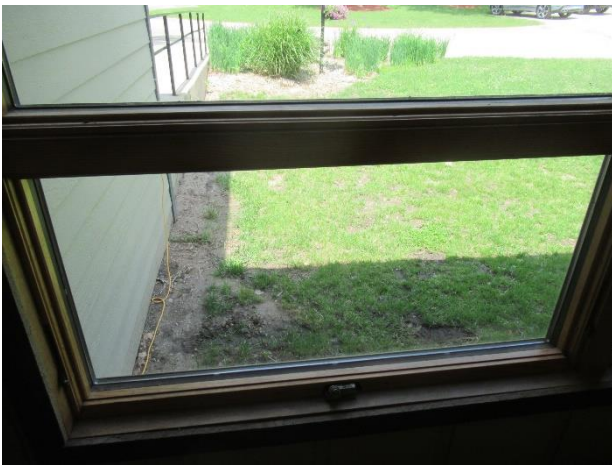
**Condition:** The lower level windows are in good condition and the upper level windows are in good to fair condition.

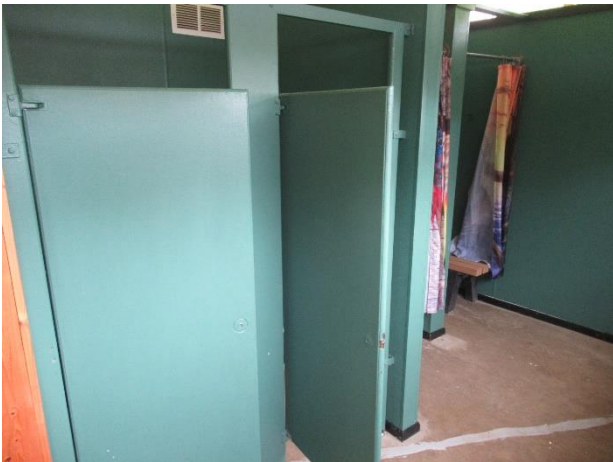
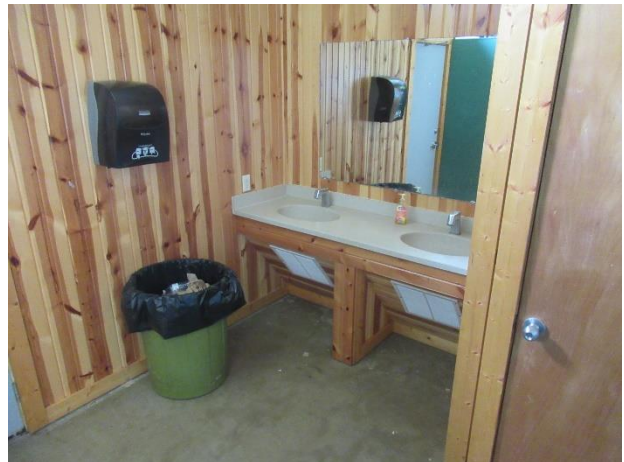
**History:** Approximately 27 years of age

**Condition:** Fair overall

**Shower room partitions**

**Shower room sinks**

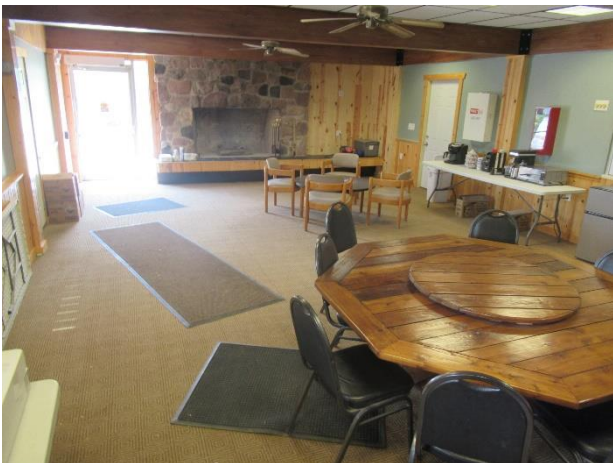
**History and Condition:** The office was recently renovated and renovation of the rest rooms was ongoing at the time of our site visit. The ages and conditions of the common area components varies. Following completion of the near-term rest room renovation, we assume good overall condition.

**Clubhouse lower level common area**

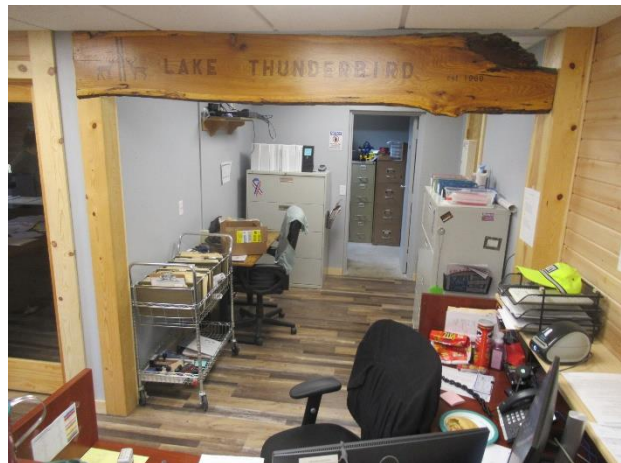
**Office finishes and equipment**

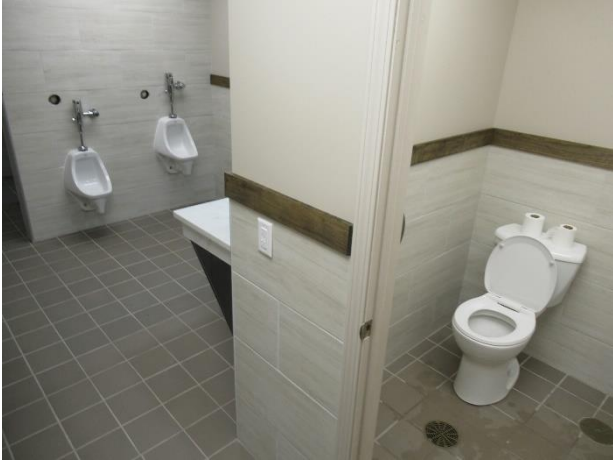
**Recently renovated rest room**

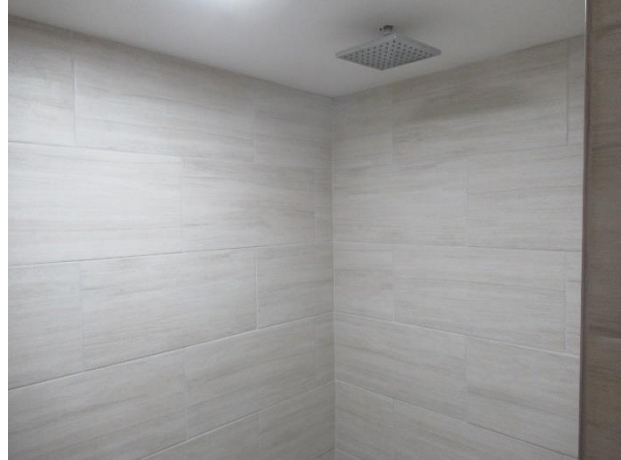
**Rest room shower area**

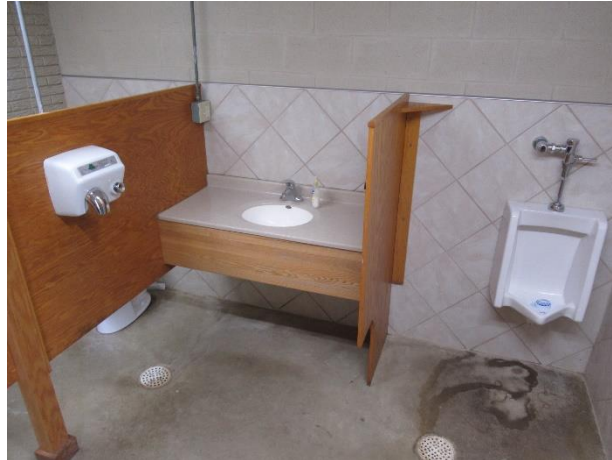
**Condition:** Following completion of the kitchen renovations, we assume good overall condition. The rest room components are in fair overall condition.

**Snack Shack rest room fixtures and partitions**

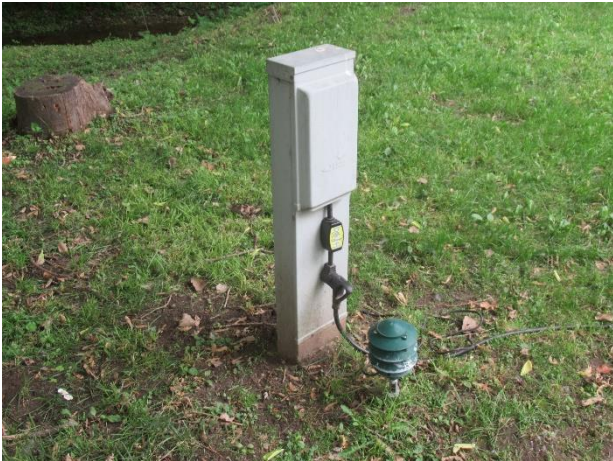
**Condition:** Management informs us the electrical system components at the campground require near-term replacement and the main panels at the clubhouse require near-term replacement.

**Campground power pedestal**

**Expenditure Detail Notes:** Expenditure timing and costs are depicted in the **Reserve Expenditures** table in Section 3. We recommend the Association budget to replace the main switchgear, distribution and circuit protection panels. Updates of this Reserve Study will consider possible changes in the scope and times of component replacements based on the conditions, including the need for replacement of the wires.

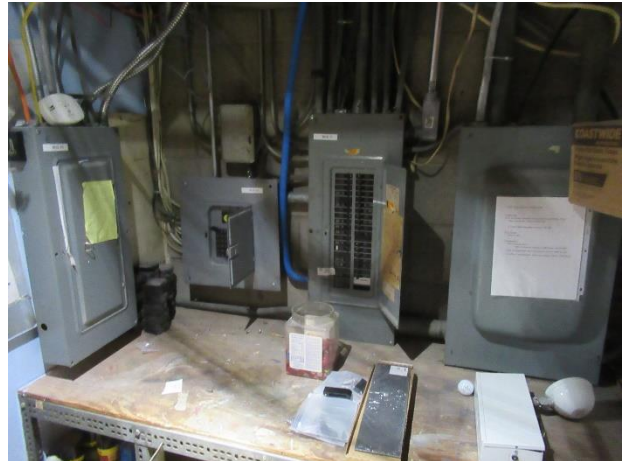
**Clubhouse electrical panels**

We recommend the Association conduct thermoscans of the distribution panels and circuit protection panels, and inspections of the transformers for any indications of arcing, burning or overheating on a regular basis, funded through the operating budget. Verification of the integrity of all connection points minimizes the potential for arcing and fires.

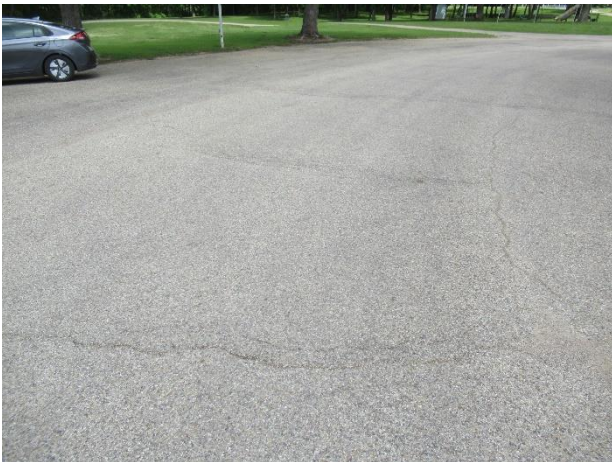
**Condition:** The parking area pavement is in fair condition with cracks and previous repairs visible throughout. The private street pavement is in good to fair condition with deterioration primarily visible at the edges and near intersections.

**Pavement cracks visible throughout clubhouse parking area**

**Useful Life:** We recommend repaving of the parking areas every 15- to 20-years with the benefit of crack repair and patch events performed periodically using funds from the operating budget. The private streets are constructed using a tar and chip technique. Therefore, we recommend chip seal applications and repairs to the private streets every five- to seven-years.

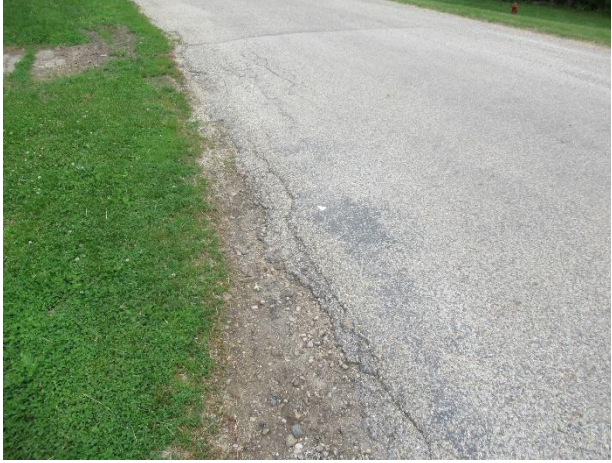
**Edge cracks at clubhouse parking area driveway**

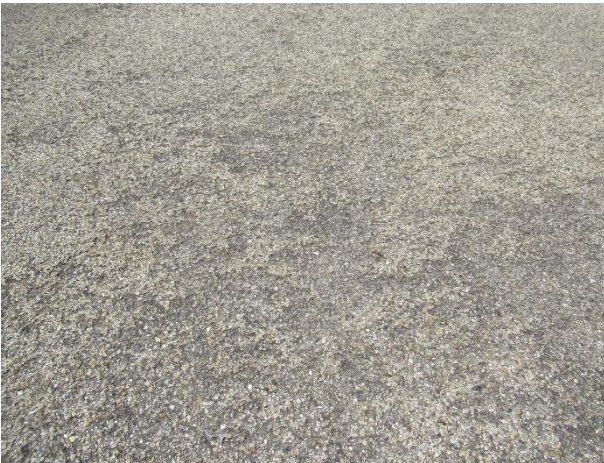
**Pavement deterioration at beach parking area**

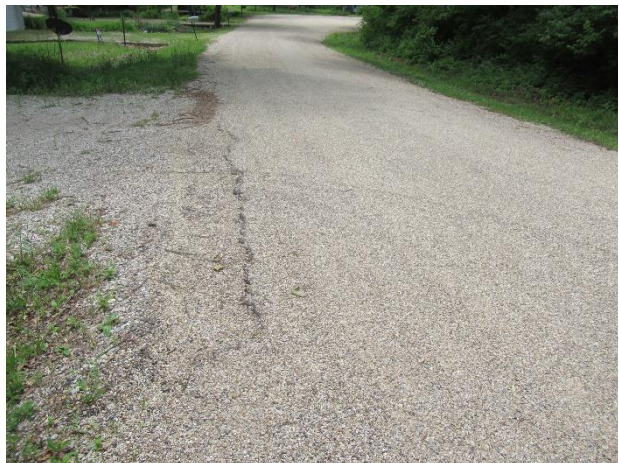
**Private street edge raveling at intersection with driveway**

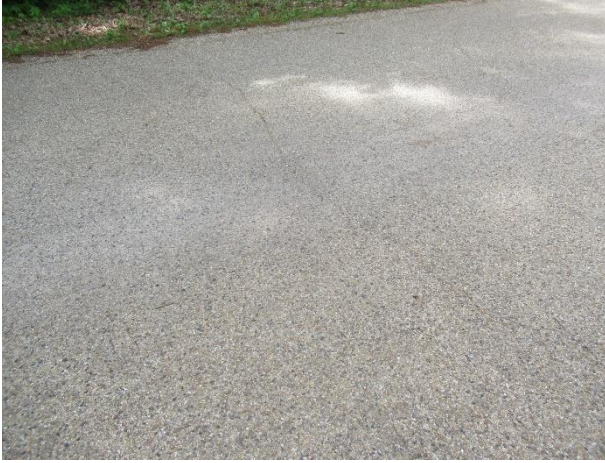
**Transverse crack and settlement at private street**

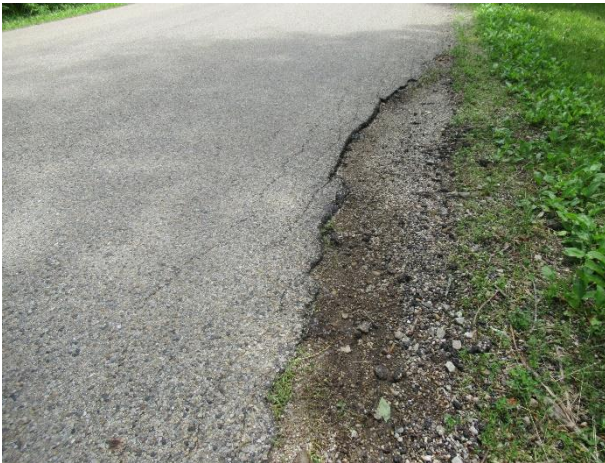
**Street edge deterioration**

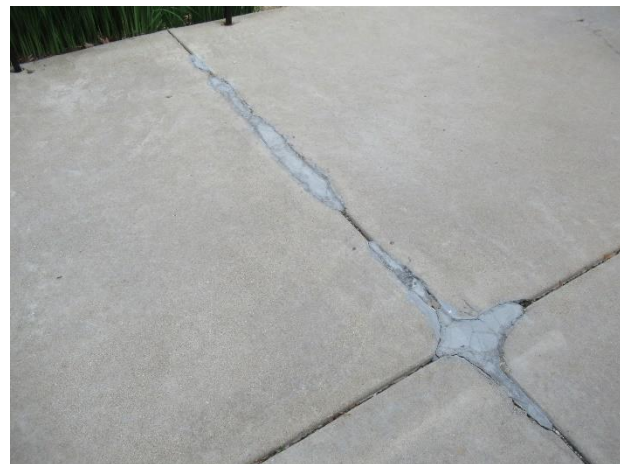
Clubhouse sidewalk repairs

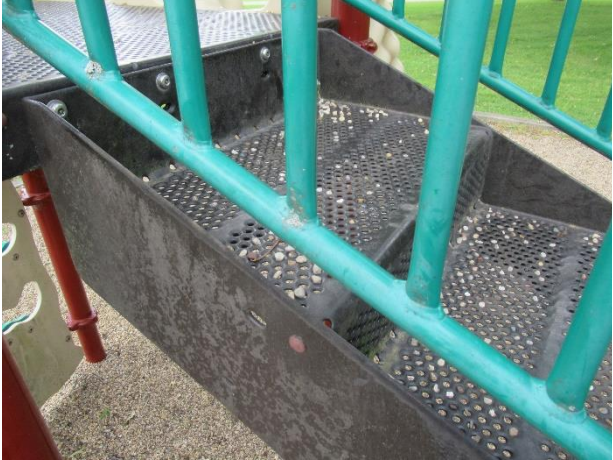
**Condition:** Fair overall

**Playset finish deterioration**

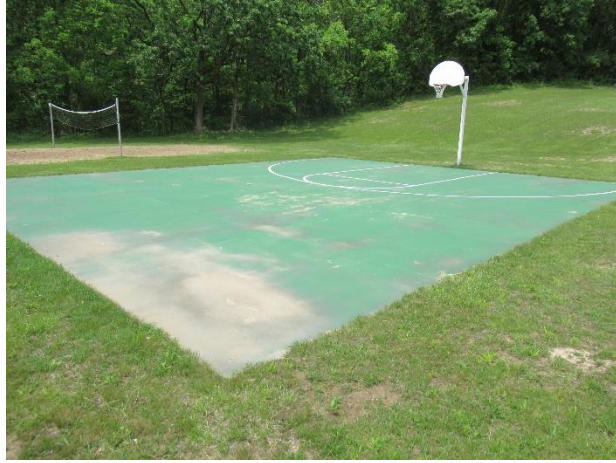
**Condition:** Poor overall with cracks and settlement visible throughout the courts

**Basketball court overview**

***Preventative Maintenance Notes:*** Prior to the application of the color coat, the Association should require the contractor to rout and fill all cracks with hot emulsion. This deters water infiltration and further deterioration of the asphalt playing surface. We note

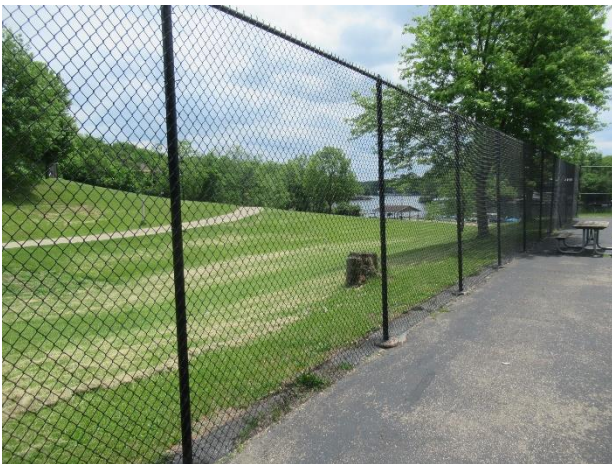
**Condition:** Poor overall

Chain link fence surrounding tennis courts

**Useful Life:** Up to 25 years. We recommend replacement in conjunction with the asphalt surface due to the interrelated nature of these events.

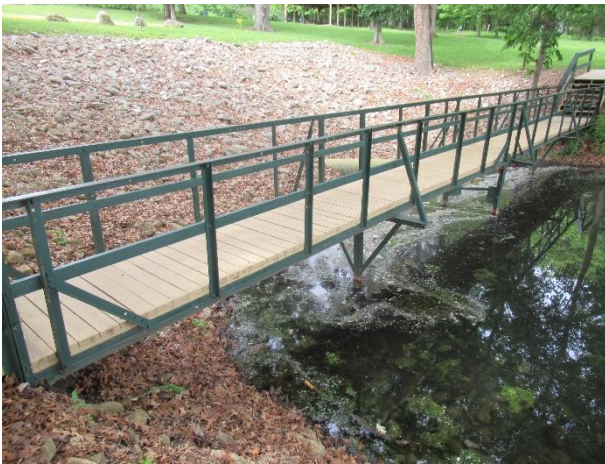
**Metal frame bridge at beach dock area**

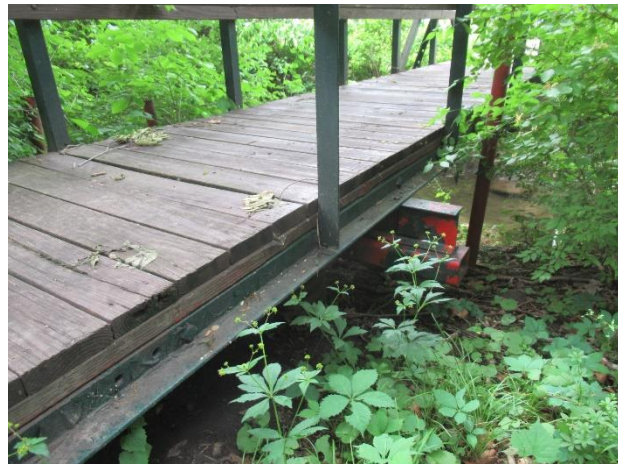
**Metal frame bridge at campground**

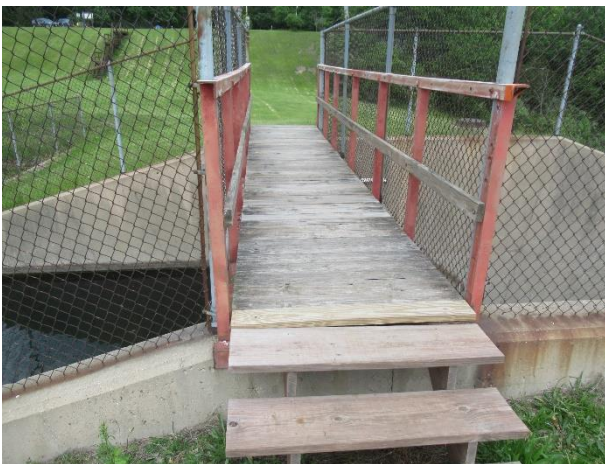
**Condition:** Good overall with the exception of the dam bridge over the spillway which exhibits finish deterioration and weathered deck boards

**Dam bridge over the spillway**

**Useful Life:** Up to 25 years. The Association should replace the deck boards and repair/paint the structures as necessary using funds from the operating budget.

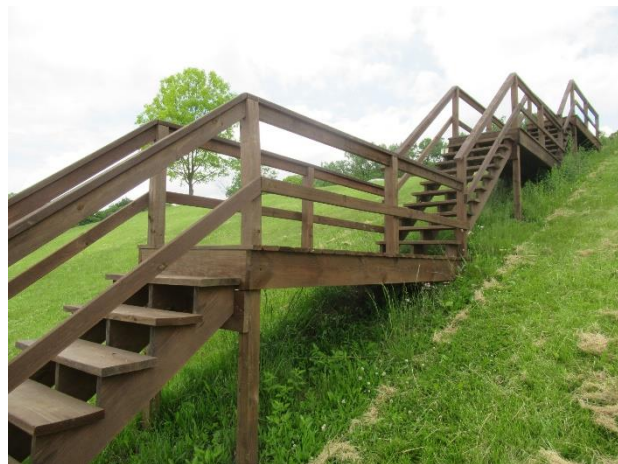
**Wood frame stairs between picnic area and dam**

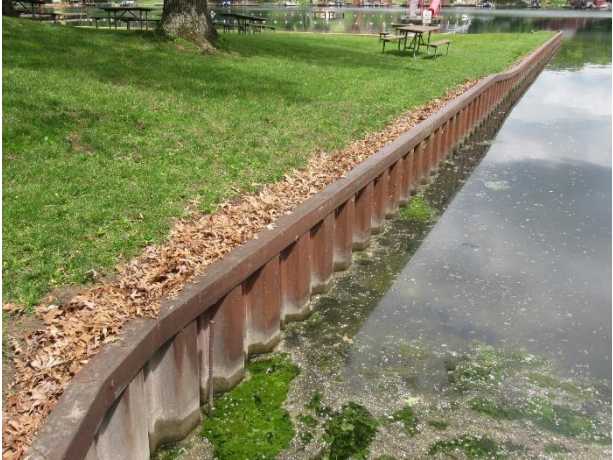
**Section of beach bulkhead in good condition**

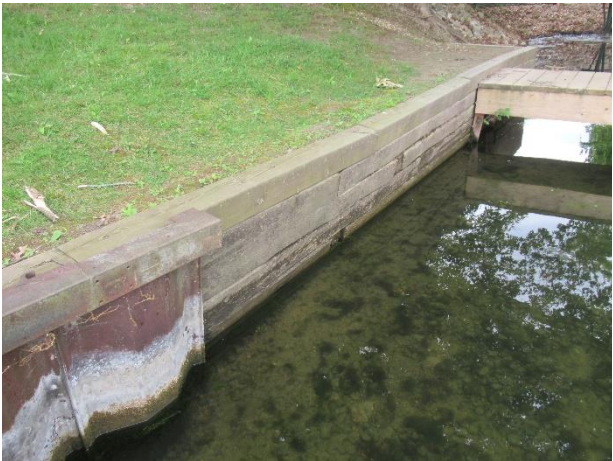
**Section of beach bulkhead comprised of wood timbers**

**Expenditure Detail Notes:** Expenditure timing and costs are depicted in the **Reserve Expenditures** table in Section 3. Our cost reflects replacement with steel pilings.

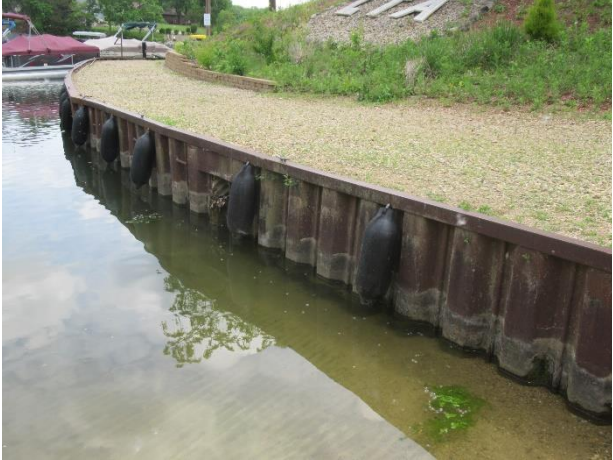
**Steel bulkhead at south boat launch**

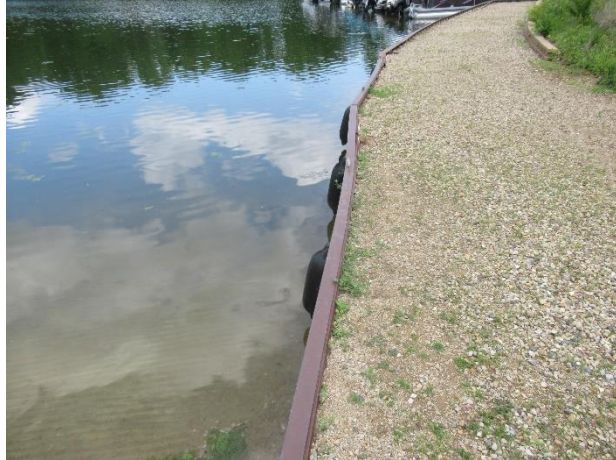
**Topside view of south boat launch bulkhead**

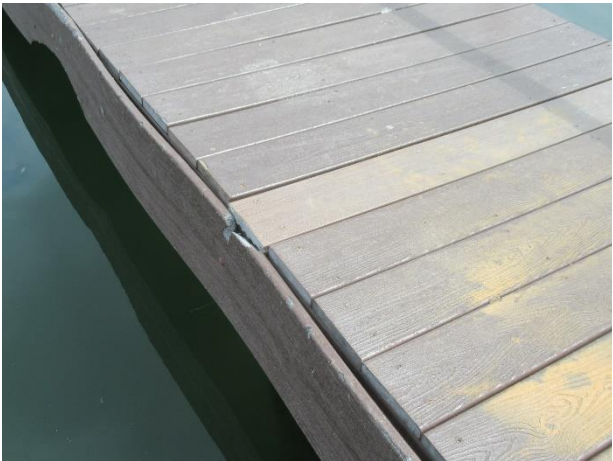
**Isolated damage and repair at beach dock**

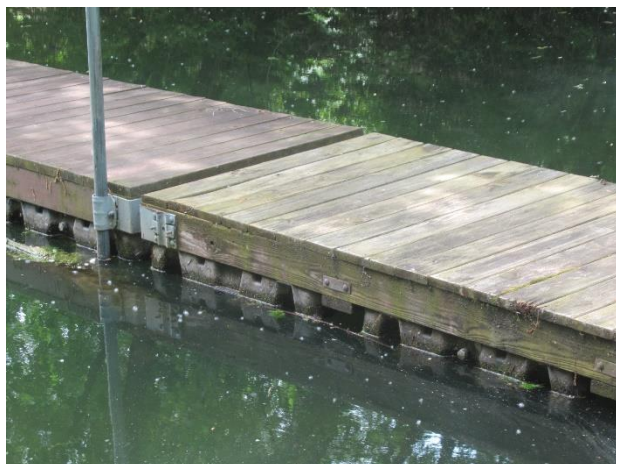
**North boat launch floating wood docks with polystyrene billets**

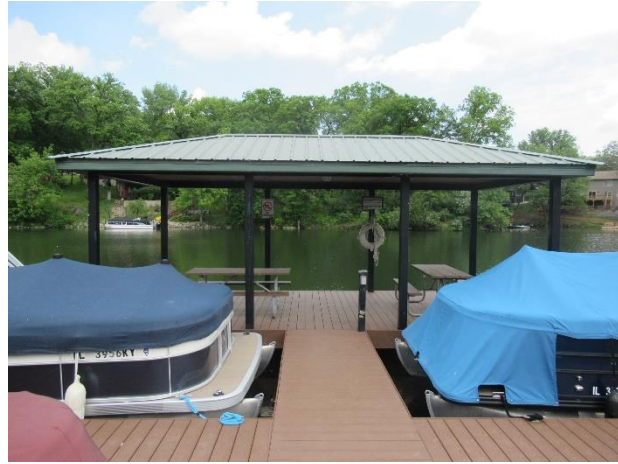
**South boat launch dock pavilion**

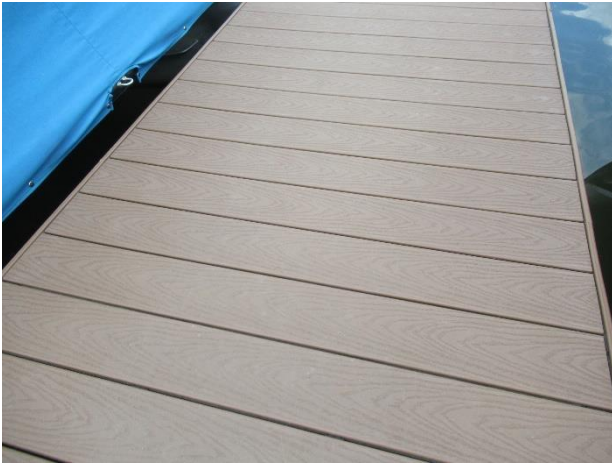
**Composite deck boards in good condition**

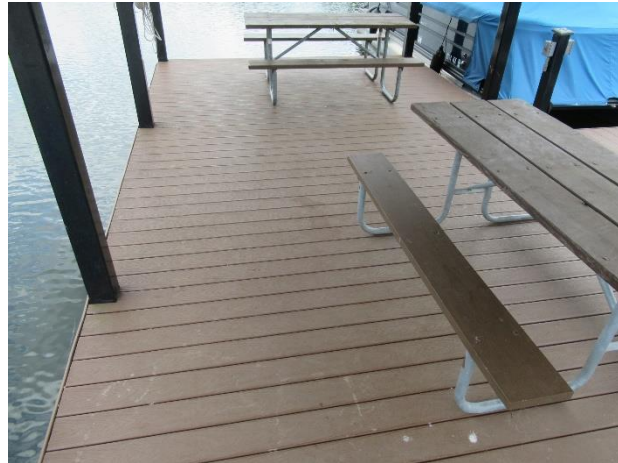
**Composite deck boards in good condition**

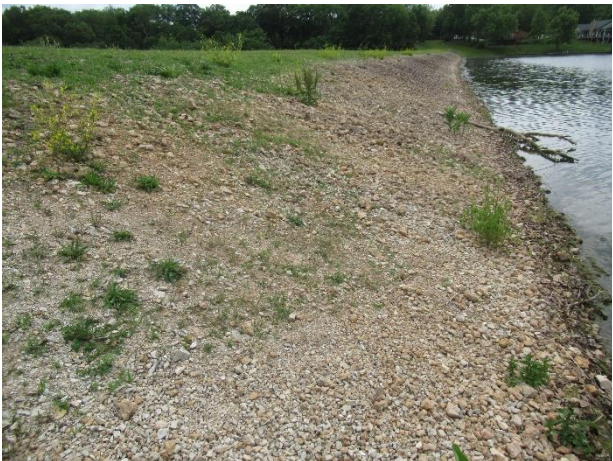
**Rip-rap erosion at front face of the dam**

**Useful Life:** We recommend the Association continue with historical practices of performing small-scale dredging projects every four years and large scale dredging projects every 25 years. We include funds to augment the rip-rap every four years. The sediment ponds require dredging on a more frequent interval (10- to 15-years).

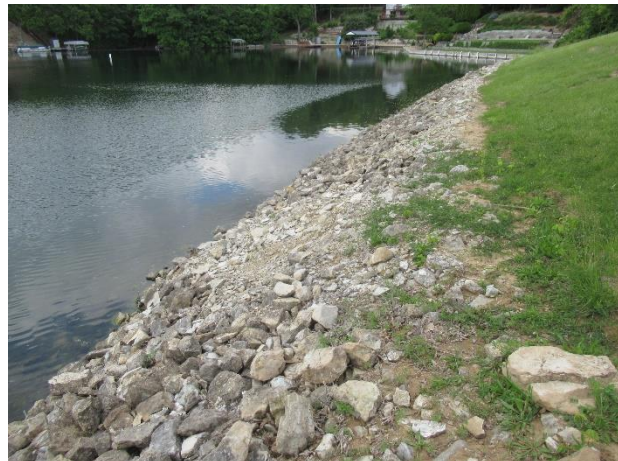
**Rip-rap at dam picnic area**

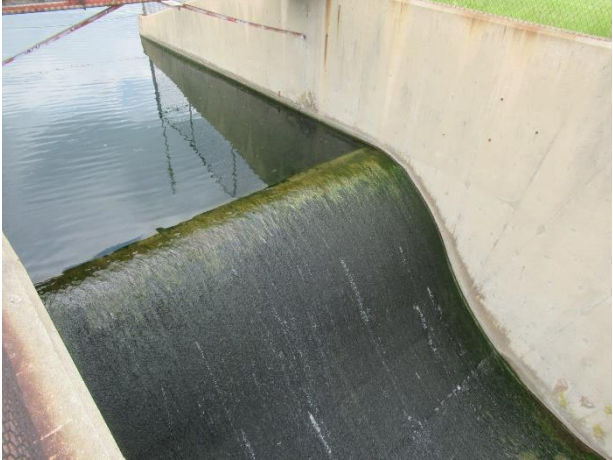
**Spillway entrance from lake**

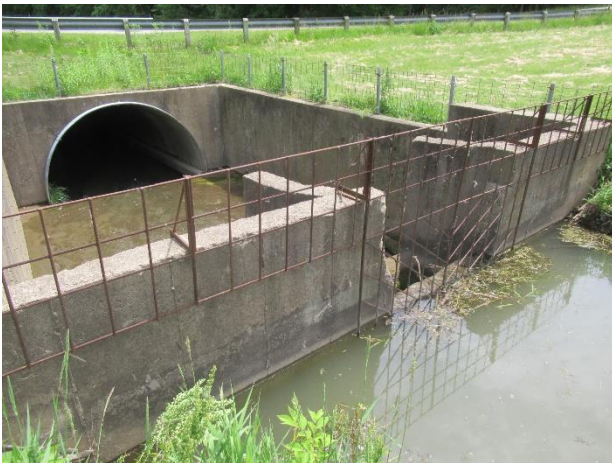
**Weir at lake inlet**

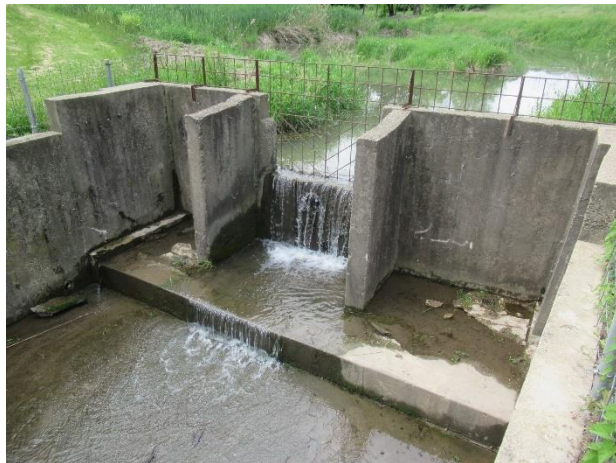
**Back side of weir at lake inlet**

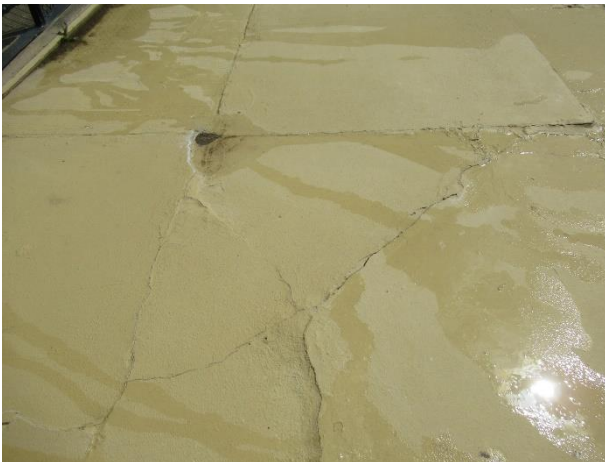
**Condition:** Fair to poor overall with cracks and repairs visible throughout the deck

**Cracks and settlement**

- Selective cut out and partial replacements of up to twenty percent (20%) of concrete
- Crack repairs as needed
- Mortar joint repairs
- Caulk replacement
- Coating replacement

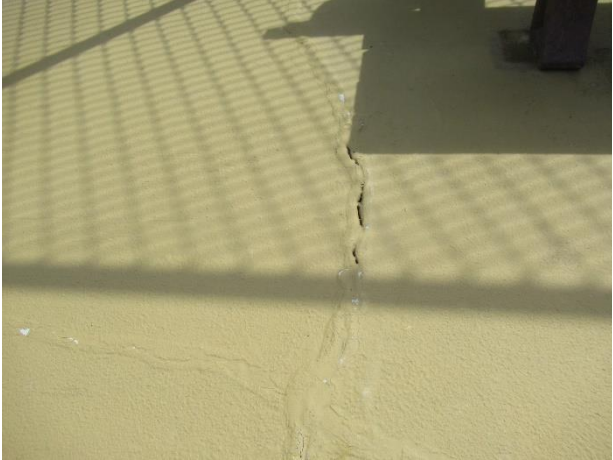
**Recurrence of crack at repaired area**

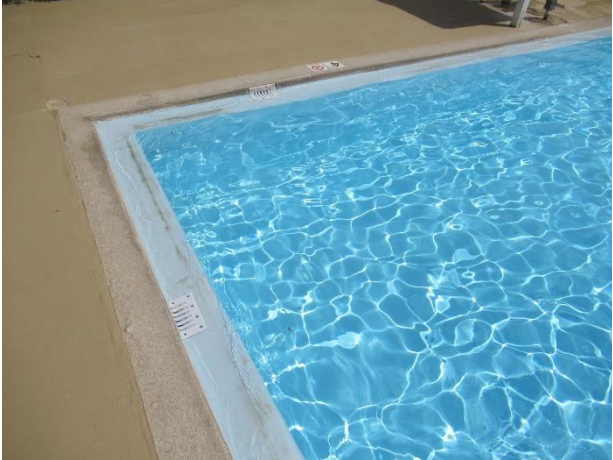
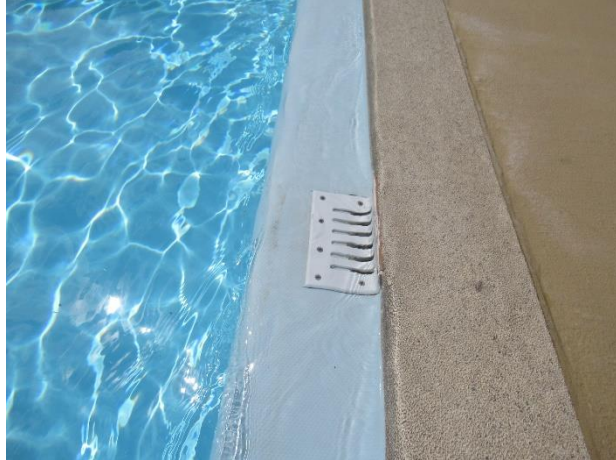
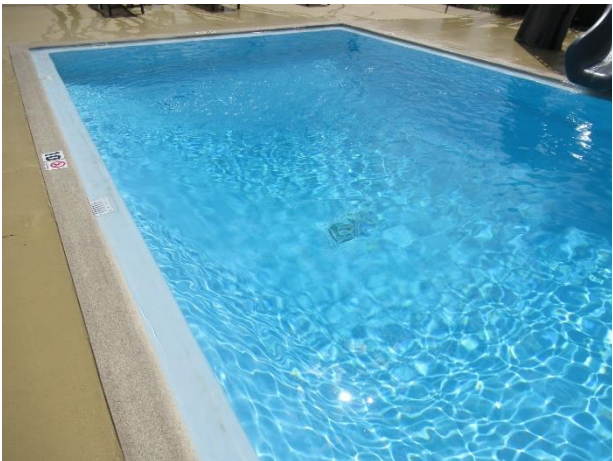
**Condition:** Good to fair overall with loose liner visible at the pool corners

**Concrete pool structure with liner**

**Liner and drain at coping area**

**Pool structure with liner**

***Expenditure Detail Notes:*** Expenditure timing and costs are depicted in the ***Reserve Expenditures*** table in Section 3. Removal and replacement of the liner provides the opportunity to inspect the pool structure and to allow for partial repairs of the underlying concrete surfaces as needed. To maintain the integrity of the pool structure, we recommend the Association budget for the following:

- Removal and replacement of the liner

- Partial replacements of the scuppers and coping as needed
- Replacement of joint sealants as needed
- Concrete structure repairs as needed

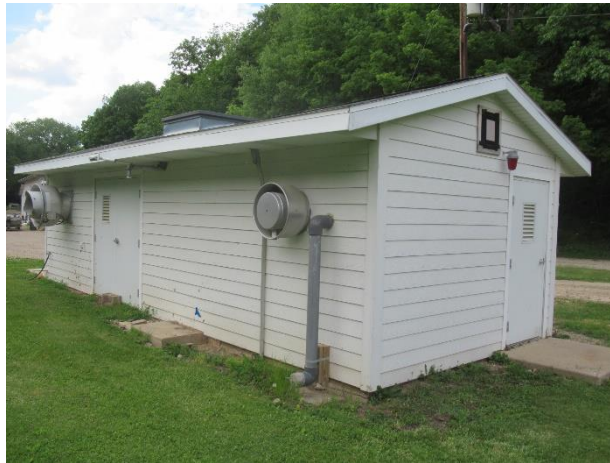
**Pump house overview**

**Condition:** Good overall

**Useful Life:** We include funds to renovate the exterior every 25 years. These renovations should include replacement of the components listed above. We recommend the Association budget for paint finishes and repairs using funds from the operating budget.

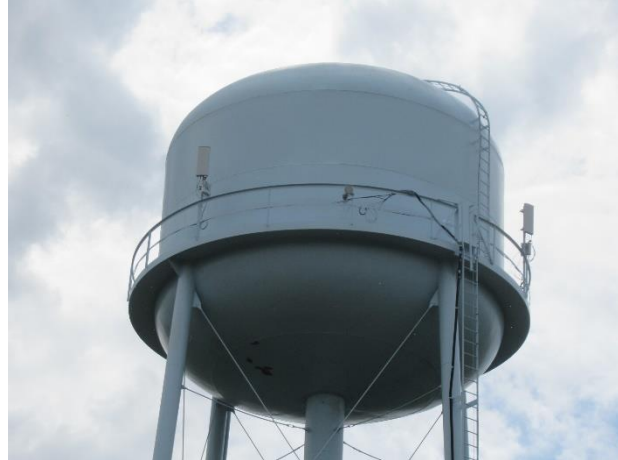
**Condition:** Fair overall

**Water tower**

**Close-up view of water storage tank**

**Useful Life:** The useful life of this component is indefinite with the benefit of ongoing paint finishes and repairs performed every five years

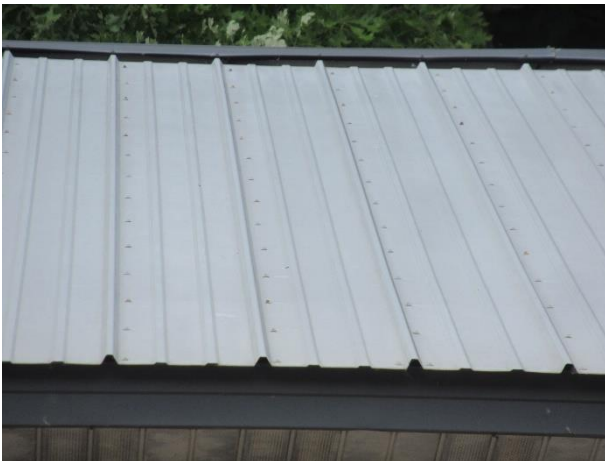
**Roof in good condition**

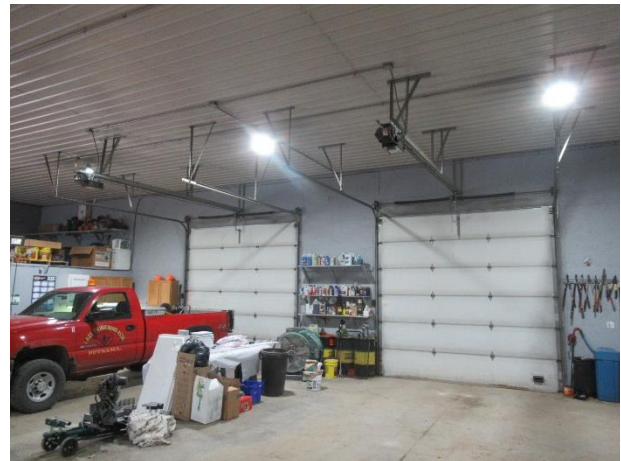
**Overhead doors and operators**

**Condition:** Good overall
