# Lake Thunderbird Association

May 29, 2025 • Putnam, IL

RESERVE STUDY

Lake Thunderbird Association  
Putnam, Illinois

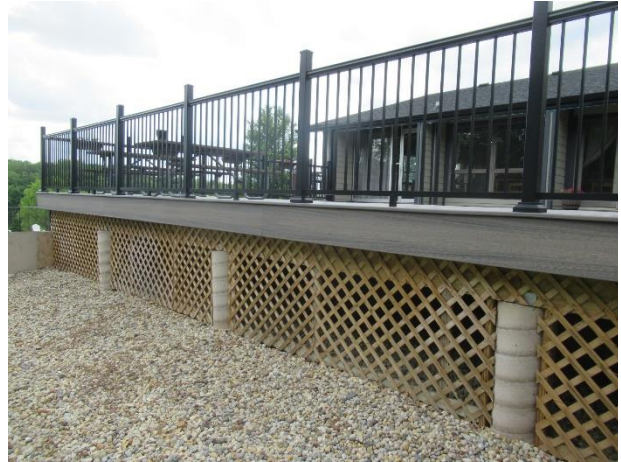
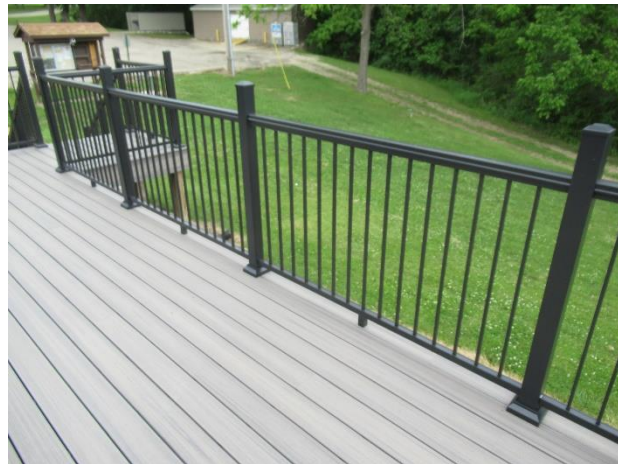
**History and Condition:** The side elevation clubhouse balcony was recently replaced and is in good condition. The ages of the remaining balconies were not provided at the time of our site visit but likely do not exceed 10 years of age. These balconies are in good to fair overall condition. We base our recommended timing of replacement based on the observed conditions.

**Deck boards in good condition**

**Underside of deck boards and wood joists at clubhouse south balcony in good condition**

**Snack Shack balcony deck boards in good condition**

**Snack Shack balcony railings in good condition**

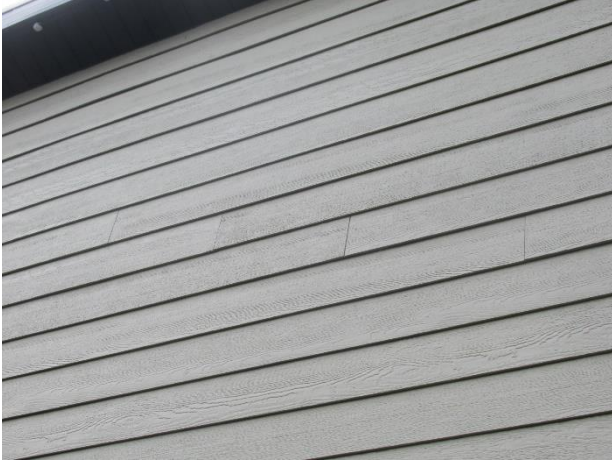
**Condition:** Good overall

**Fiber cement siding with a lap profile**

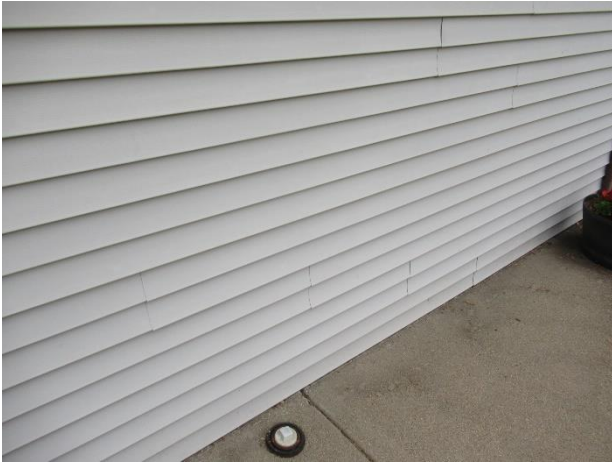
**Condition:** Fair overall

**Vinyl siding with a clapboard profile at campground shower building**

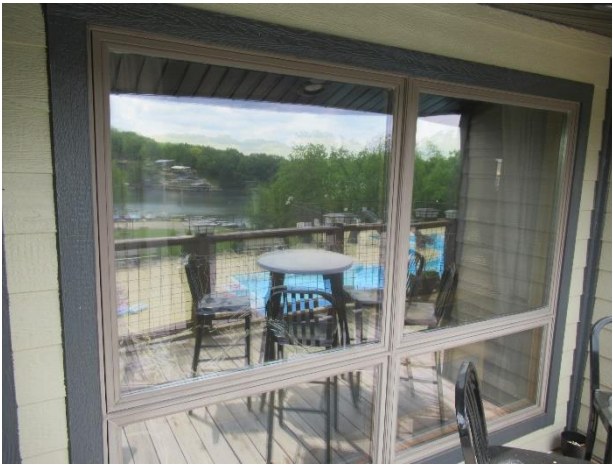
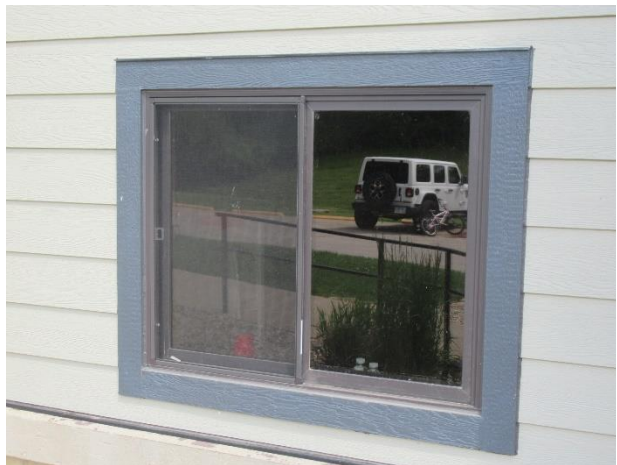
**Condition:** The lower level windows are in good condition and the upper level windows are in good to fair condition.

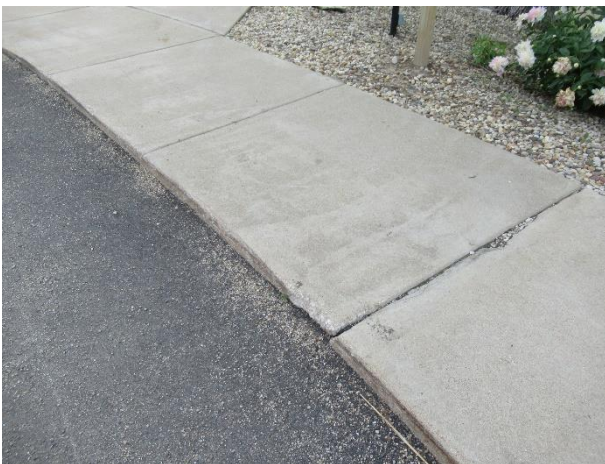
**Condition:** Fair overall; Management informs us of the likelihood of near-term replacement to comply with ADA standards. Therefore, we include an allocation for replacement in conjunction with repaving of the parking area. Following completion of this project, we recommend concrete replacements to be funded through the operating budget due to limited quantities and costs.

Clubhouse front elevation sidewalk adjacent to parking area

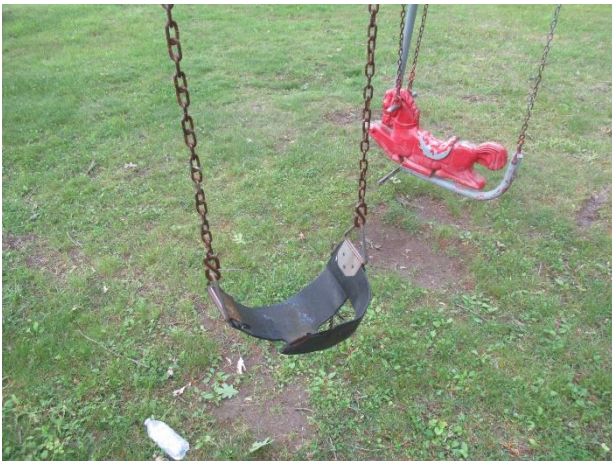
**Condition:** Fair overall

**Swing deterioration**

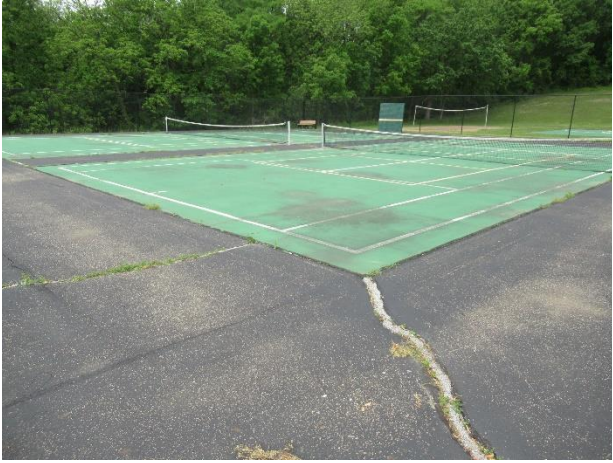
**Condition:** Poor overall with cracks and settlement visible throughout the courts

**Tennis court overview**

**Useful Life:** Up to 25 years for replacement of the surface with the benefit of color coat applications and repairs every four- to six-years

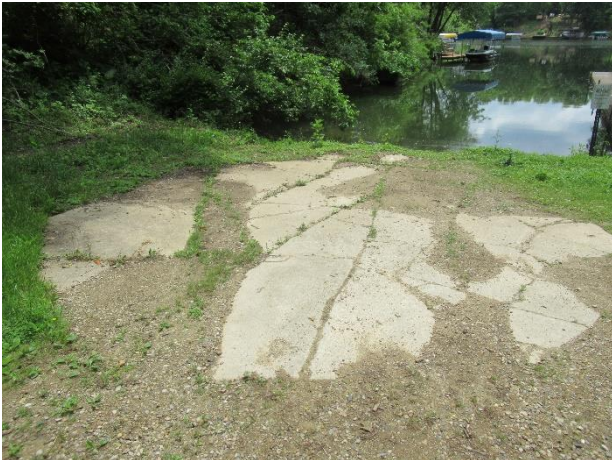
**Condition:** The south concrete is in good overall condition and the north concrete is in poor overall condition

North boat launch ramp

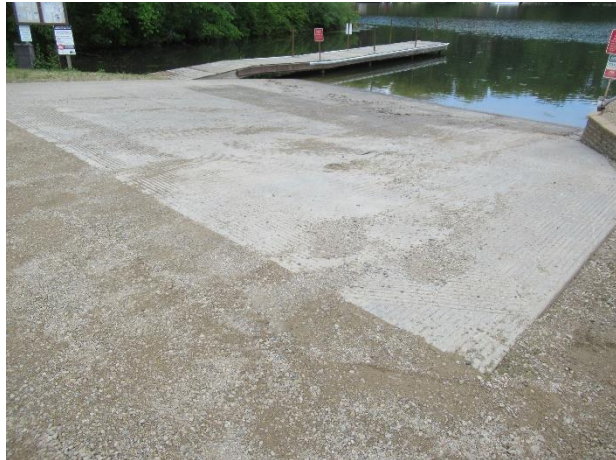
South boat launch ramp

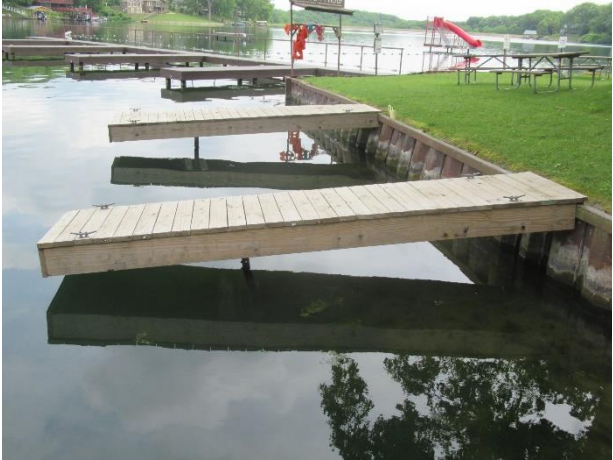
**Wood beach docks**

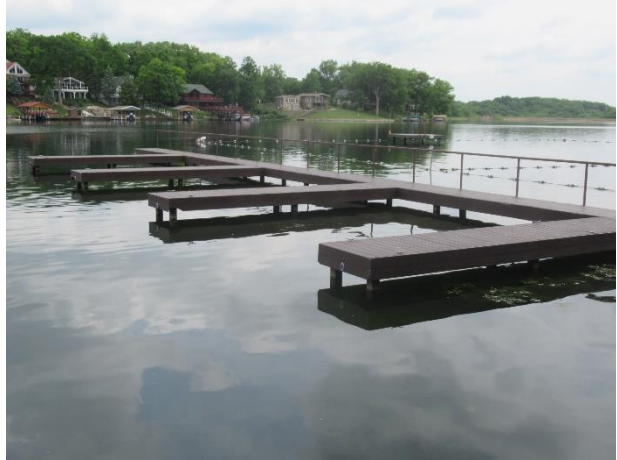
**Composite beach docks**

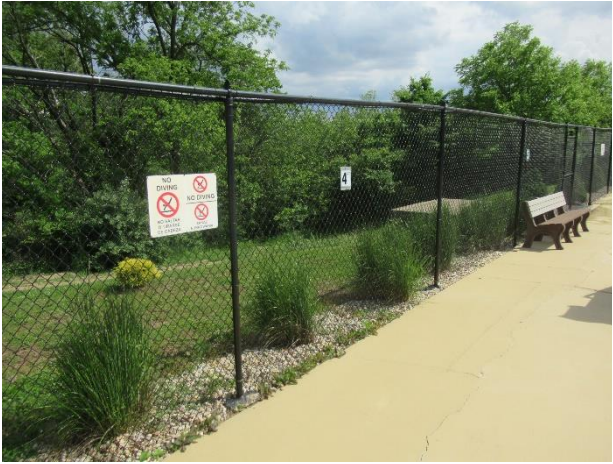
**Condition:** Good overall

**Chain link fence surrounding pool**

- Annually:
  - Inspect and repair loose sections, and damage
  - Repair leaning sections and clear vegetation from fence areas which could cause damage

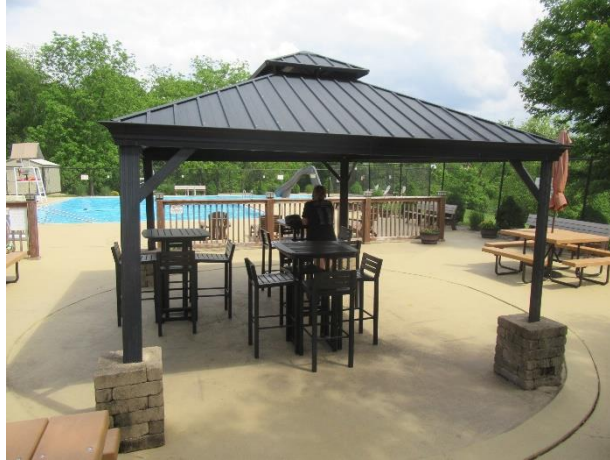
**Condition:** Good overall

**Pool furniture and pavilion (the pavilion structure and roof has an indefinite life span)**

**Expenditure Detail Notes:** Expenditure timing and costs are depicted in the **Reserve Expenditures** table in Section 3. Due to the varied ages and usages of the furniture, we include a phased replacement of up to fifty percent (50%) per event. We recommend interim re-strapping, refinishing, cushion replacements, reupholstering and other repairs to the furniture as normal maintenance to maximize its useful life.

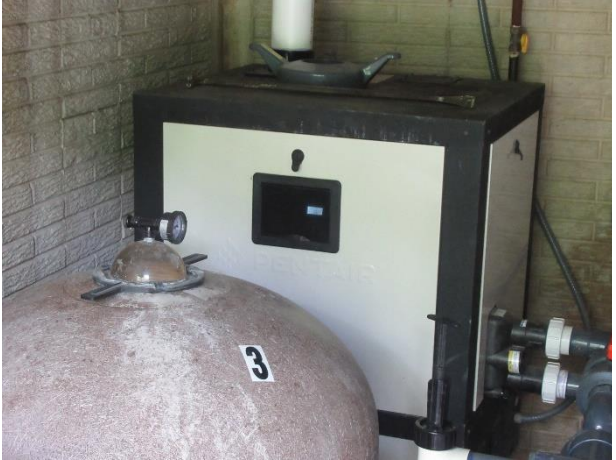
**Pool heater**

**Condition:** Reported satisfactory

**Preventative Maintenance Notes:** We recommend the Association maintain a maintenance contract with a qualified professional and follow the manufacturer's specific recommended maintenance and local, state and/or federal inspection guidelines.

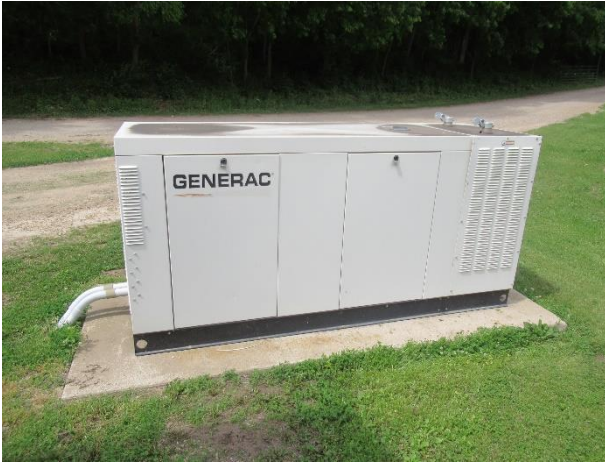
**Generator**

**Condition:** Reported satisfactory without operational deficiencies

**Expenditure Detail Notes:** Expenditure timing and costs are depicted in the **Reserve Expenditures** table in Section 3. Our estimate of cost includes replacement of the transfer switch. We recognize that the transfer switch may require replacement prior to the replacement of the generator. For purposes of this Reserve Study, we assume coordination of replacement with the generator.

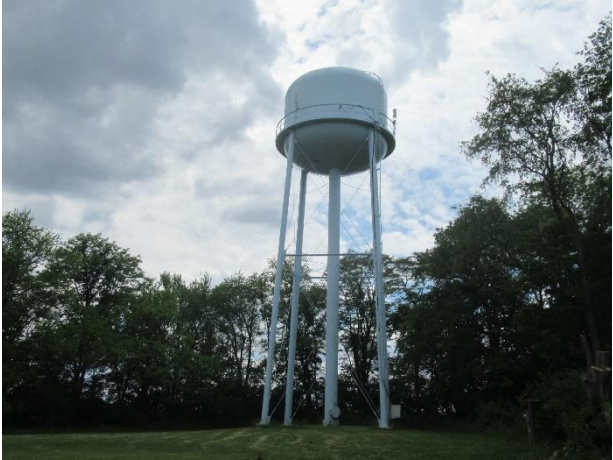
**Condition:** Fair overall

**Water tower**

**Close-up view of water storage tank**

**Useful Life:** The useful life of this component is indefinite with the benefit of ongoing paint finishes and repairs performed every five years

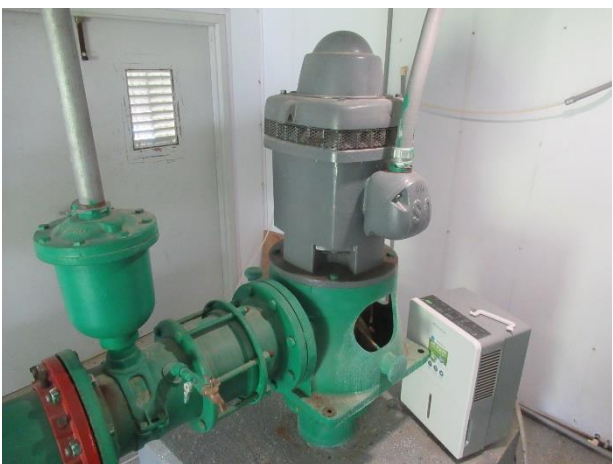
**Well pump**

**History:** The age of the well casing was not provided at the time of our site visit. The pump is approximately 20 years of age and the controls were recently replaced.

**Condition:** Reported satisfactory

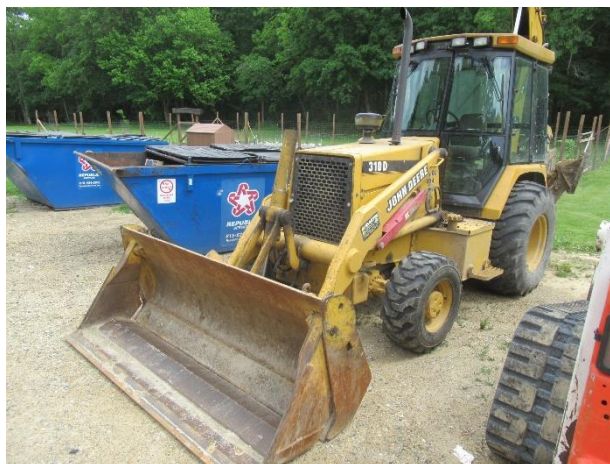
**Backhoe**

**Condition:** Reported satisfactory

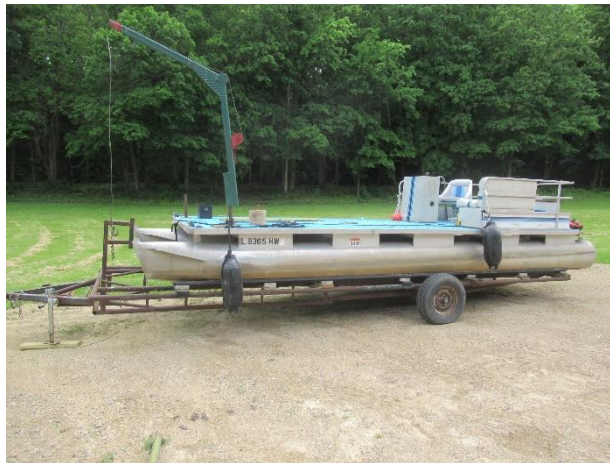
**Pontoon boat**

**Condition:** Reported satisfactory

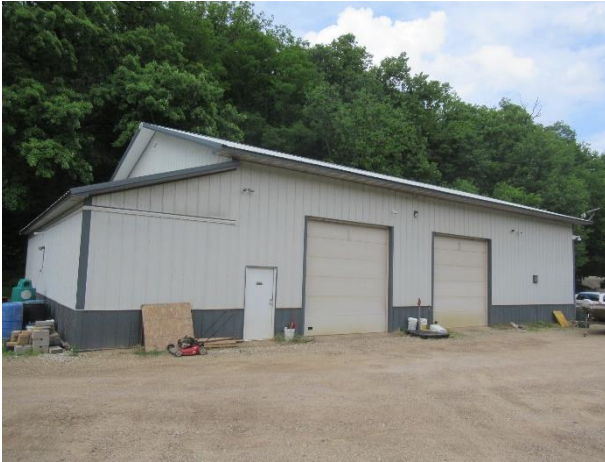
**Maintenance shop**

**Condition:** Good overall

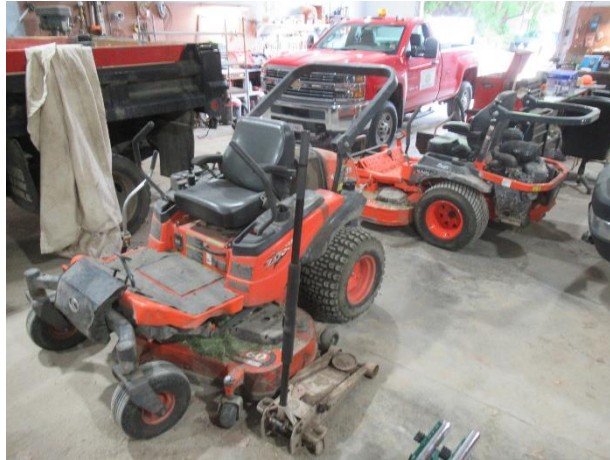
**Zero-turn mowers**

**Condition:** Reported satisfactory

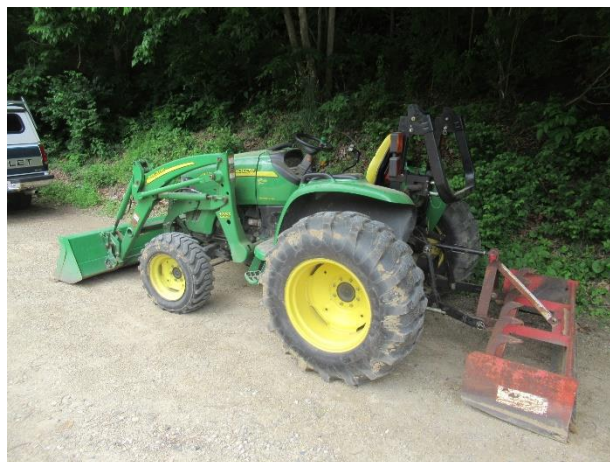
**Tractor**

**Condition:** Reported satisfactory

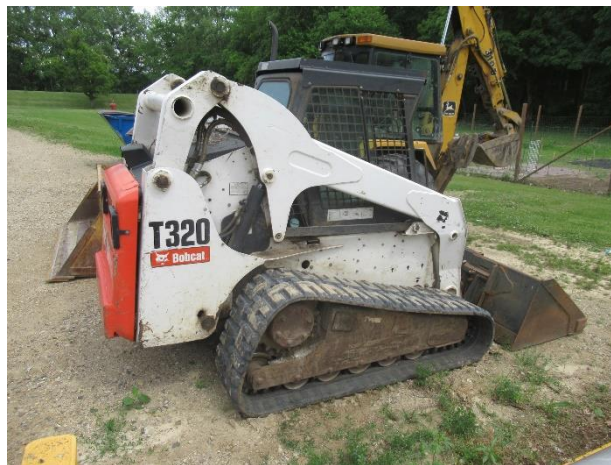
**Skidsteer**

**Condition:** Reported satisfactory

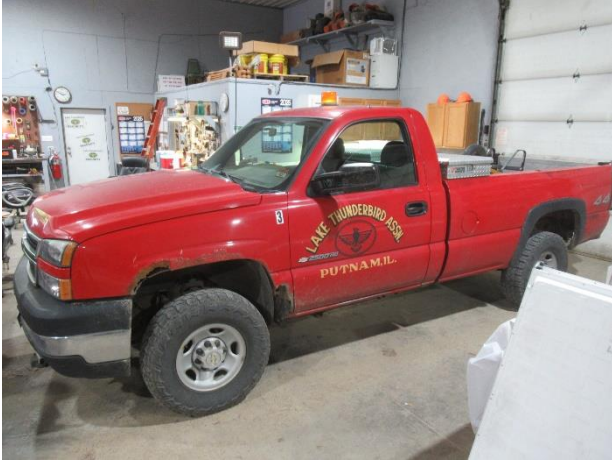
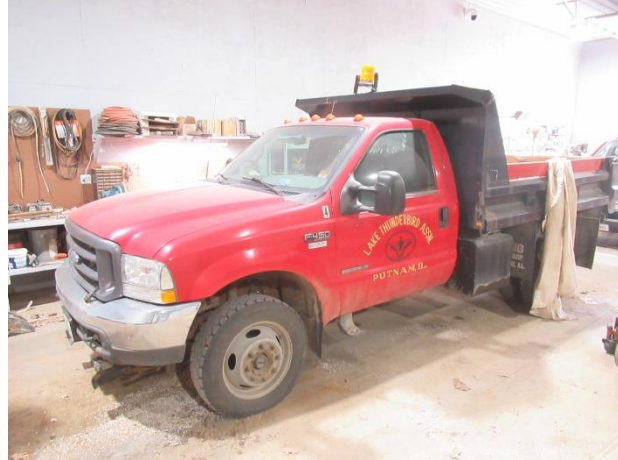
**Condition:** Management informs us of the necessity of one near-term replacement

***Chevrolet utility truck***

***Ford utility truck***
